# Access Compliance Report

## Public Rights-of-Way

### (Curb Ramps)

Intersection ID: 30548	Main Street: SOUTH_BV	Cross Street: N/A	Location: SE
ADA ID: 644549393726	Ramp Type: Perp	Initial Pass/Fail: Pass	Overall Compliance: No
Codes/Mitigation Info/Possible Solution		Field Measurements/Component Compliance	
Severity Score: 12.75

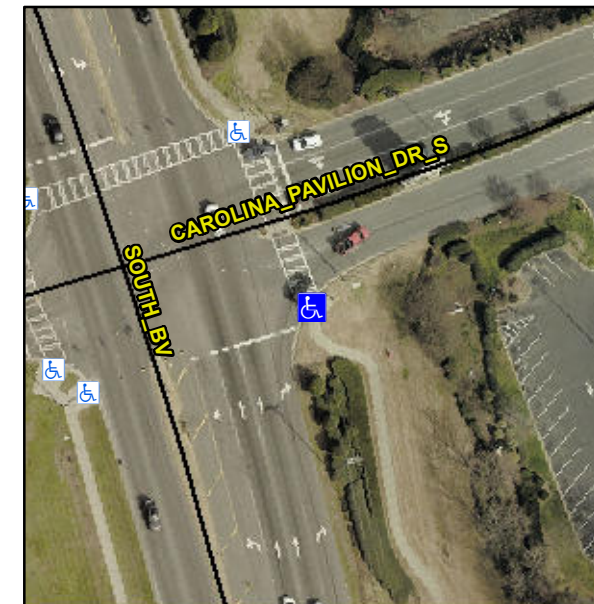
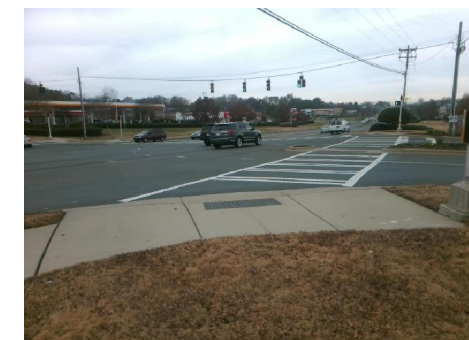
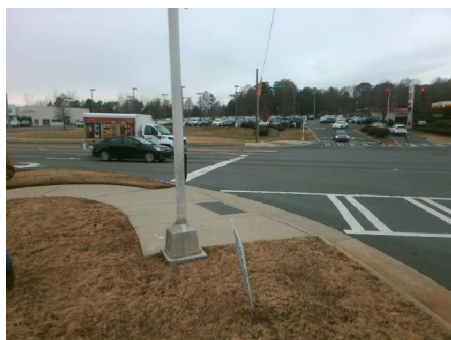
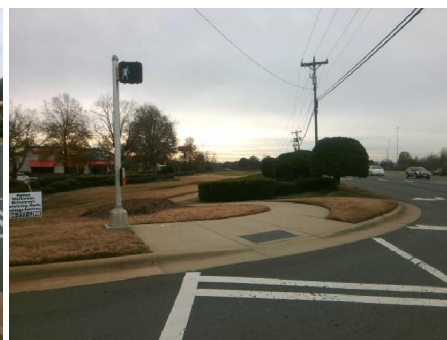
**R304.2.1, R304.2.2-Perp, R304.3.2-Para, R304.5.3, R305.1.4, R305.2**

Compliance	Description	Data	Compliance	Description	Data
N/A	Ramp Length (in)	94.0	Yes	Ramp Slope (%)	6.2
Yes	Ramp Width (in)	60.0	Yes	Ramp XSlope (%)	2.9
N/A	Flare Type LT	Sloped	N/A	Flare Type RT	N/A
N/A	Flare Slope LT (%)	5.2	Yes	Flare Slope RT (%)	5.0
N/A	Flare Traversable LT?	Yes	N/A	Flare Traversable RT?	Yes
No	Landing Length (in)	N/A	Yes	DWS Provided?	Yes
No	Landing Width (in)	N/A	Yes	DWS Contrast?	Yes
No	Landing Slope (%)	N/A	Yes	DWS Length (in)	24.0
No	Landing X Slope (%)	N/A	No	DWS Full Width?	No
N/A	Landing Curb? (Y/N)	No	No	DWS Offset (in)	5.0
N/A	Shared Landing?	No			
Yes	Gutter Ponding?	No	Yes	Gutter Slope (%)	0.2
Yes	Gutter Lip Ht (in)	0.0	Yes	Gutter X Slope (%)	0.7
N/A	Painted X Walk1?	Yes	N/A	Painted X Walk2?	N/A
	X Walk 1 Direction	To N		X Walk 2 Direction	N/A
N/A	X Walk 1 Width (in)	134.0	N/A	X Walk 2 Width (in)	N/A
	X Walk 1 Slope (%)	2.3		X Walk 2 Slope (%)	N/A
	X Walk 1 X Slope (%)	3.0		X Walk 2 X Slope (%)	N/A

Yes	Ramp inside XWalk1?	Yes	N/A	Ramp inside XWalk2?	N/A
	Road Slope (%)	N/A	N/A	Clear Space?	Yes
	Road X Slope (%)	N/A	N/A	Clear Space to XWalk (in)	N/A
Yes	Any Obstructions?	No	Yes	Storm Grate/Utility Hazard?	No
	Obstruction Type			Storm Grate/Utility Type	
		N/A			N/A
			Yes	Surface Condition? (G/P)	Good

**Remove & Replace Entire Ramp.**

Total Cost: \$ 1850.00
