# Access Compliance Report

## Public Rights-of-Way

### (Curb Ramps)

Intersection ID: 7022	Main Street: CROSSPOINT_CENTER_LN	Cross Street: HUTCHISON-MCDONALD_RD	Location: NW
ADA ID: 6446B7083CB5	Ramp Type: Perp	Initial Pass/Fail: Fail	Overall Compliance: No
Severity Score: 13.75			
Codes/Mitigation Info/Possible Solution		Field Measurements/Component Compliance

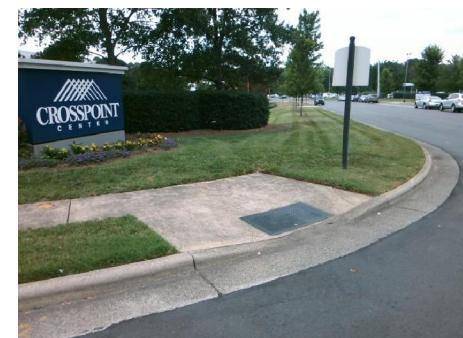
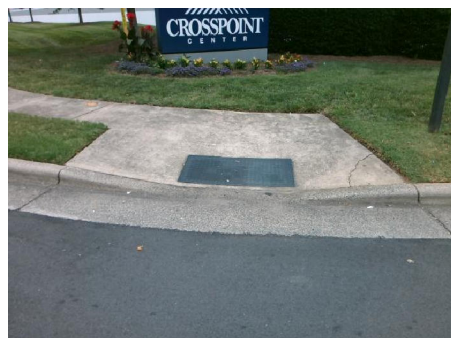
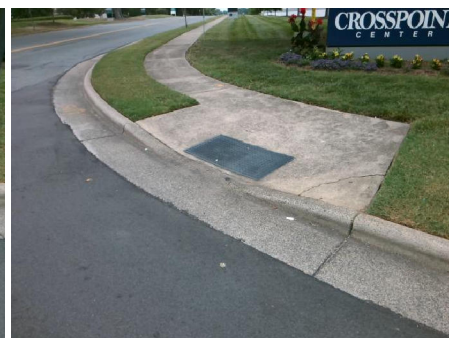
**Not Found, R304.2.2, R304.5.3**

Compliance	Description	Data	Compliance	Description	Data
N/A	Ramp Length (in)	95.5	No	Ramp Slope (%)	9.0
Yes	Ramp Width (in)	48.0	No	Ramp XSlope (%)	2.1
N/A	Flare Type LT	N/A	N/A	Flare Type RT	N/A
N/A	Flare Slope LT (%)	N/A	N/A	Flare Slope RT (%)	N/A
N/A	Flare Traversable LT?	N/A	N/A	Flare Traversable RT?	N/A
N/A	Landing Length (in)	N/A	N/A	DWS Provided?	N/A
N/A	Landing Width (in)	N/A	N/A	DWS Contrast?	N/A
N/A	Landing Slope (%)	N/A	N/A	DWS Length (in)	N/A
N/A	Landing X Slope (%)	N/A	N/A	DWS Full Width?	N/A
N/A	Landing Curb? (Y/N)	N/A	N/A	DWS Offset (in)	N/A
N/A	Shared Landing?	N/A			
N/A	Gutter Ponding?	N/A	N/A	Gutter Slope (%)	N/A
N/A	Gutter Lip Ht (in)	N/A	N/A	Gutter X Slope (%)	N/A
N/A	Painted X Walk1?	No	N/A	Painted X Walk2?	N/A
	X Walk 1 Direction	To E		X Walk 2 Direction	N/A
N/A	X Walk 1 Width (in)	N/A	N/A	X Walk 2 Width (in)	N/A
	X Walk 1 Slope (%)	0.2		X Walk 2 Slope (%)	N/A
	X Walk 1 X Slope (%)	2.8		X Walk 2 X Slope (%)	N/A

N/A	Ramp inside XWalk1?	N/A	N/A	Ramp inside XWalk2?	N/A
	Road Slope (%)	N/A	N/A	Clear Space?	N/A
	Road X Slope (%)	N/A	N/A	Clear Space to XWalk (in)	N/A
N/A	Any Obstructions?	N/A	N/A	Storm Grate/Utility Hazard?	N/A
	Obstruction Type			Storm Grate/Utility Type	
		N/A			N/A
			Yes	Surface Condition? (G/P)	Good

Possible Solutions:

**Remove & Replace Entire Ramp.**
