Access Compliance Report

Public Rights-of-Way

(Curb Ramps)

Intersection ID: 10025998	Main Street: ELMSTONE_DR	Cross Street: N/A	Location: S
ADA ID: 645494A9B835	Ramp Type: Perp	Initial Pass/Fail: Fail	Overall Compliance: No
Severity Score: 33.75			
Codes/Mitigation Info/Possible Solution		Field Measurements/Component Compliance

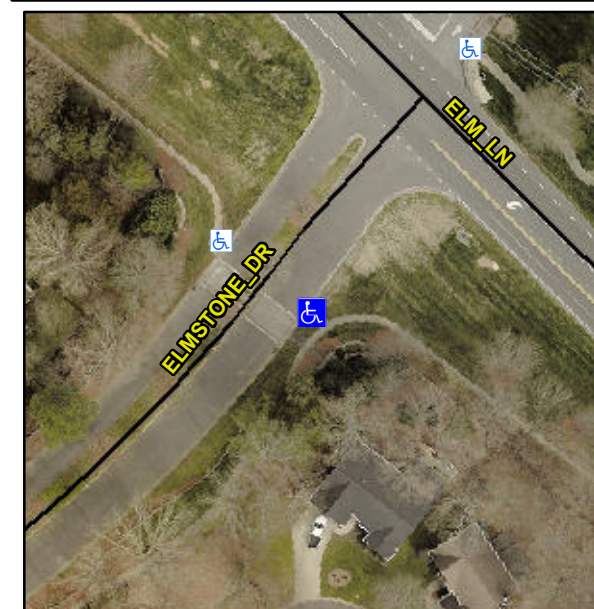
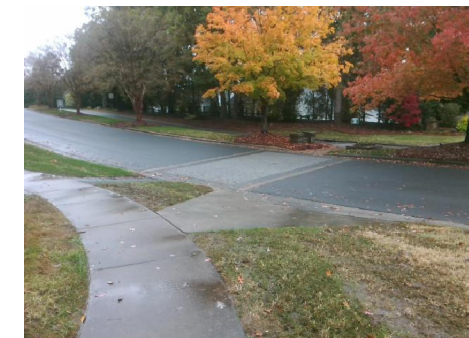
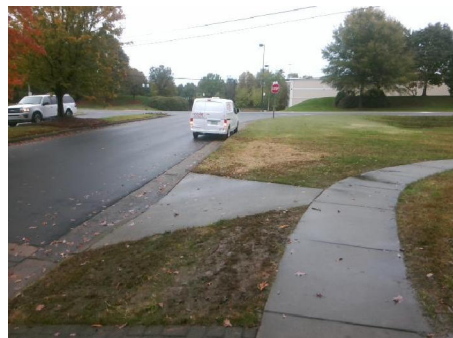
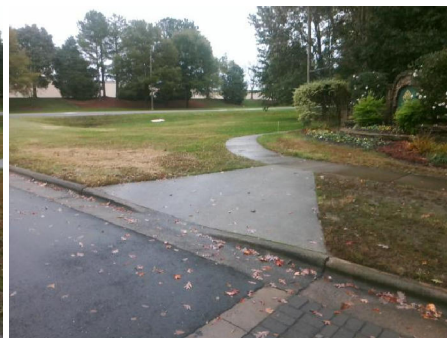
Not Found, R304.5.1, R304.2.2

Compliance	Description	Data	Compliance	Description	Data
N/A	Ramp Length (in)	122.5	No	Ramp Slope (%)	13.6
No	Ramp Width (in)	47.0	Yes	Ramp XSlope (%)	0.6
N/A	Flare Type LT	N/A	N/A	Flare Type RT	N/A
N/A	Flare Slope LT (%)	N/A	N/A	Flare Slope RT (%)	N/A
N/A	Flare Traversable LT?	N/A	N/A	Flare Traversable RT?	N/A
N/A	Landing Length (in)	N/A	N/A	DWS Provided?	N/A
N/A	Landing Width (in)	N/A	N/A	DWS Contrast?	N/A
N/A	Landing Slope (%)	N/A	N/A	DWS Length (in)	N/A
N/A	Landing X Slope (%)	N/A	N/A	DWS Full Width?	N/A
N/A	Landing Curb? (Y/N)	N/A	N/A	DWS Offset (in)	N/A
N/A	Shared Landing?	N/A			
N/A	Gutter Ponding?	N/A	N/A	Gutter Slope (%)	N/A
N/A	Gutter Lip Ht (in)	N/A	N/A	Gutter X Slope (%)	N/A
N/A	Painted X Walk1?	No	N/A	Painted X Walk2?	N/A
	X Walk 1 Direction	To NW		X Walk 2 Direction	N/A
N/A	X Walk 1 Width (in)	N/A	N/A	X Walk 2 Width (in)	N/A
	X Walk 1 Slope (%)	1.5		X Walk 2 Slope (%)	N/A
	X Walk 1 X Slope (%)	3.6		X Walk 2 X Slope (%)	N/A

N/A	Ramp inside XWalk1?	N/A	N/A	Ramp inside XWalk2?	N/A
	Road Slope (%)	N/A	N/A	Clear Space?	N/A
	Road X Slope (%)	N/A	N/A	Clear Space to XWalk (in)	N/A
N/A	Any Obstructions?	N/A	N/A	Storm Grate/Utility Hazard?	N/A
	Obstruction Type			Storm Grate/Utility Type	
		N/A			N/A
			Yes	Surface Condition? (G/P)	Good

Possible Solutions:

Remove & Replace Entire Ramp.
