# Access Compliance Report

## Public Rights-of-Way

### (Curb Ramps)

| Intersection ID: 14431 | Main Street: N_COLONIAL_AV | Cross Street: RANDOLPH_RD | Location: NE |

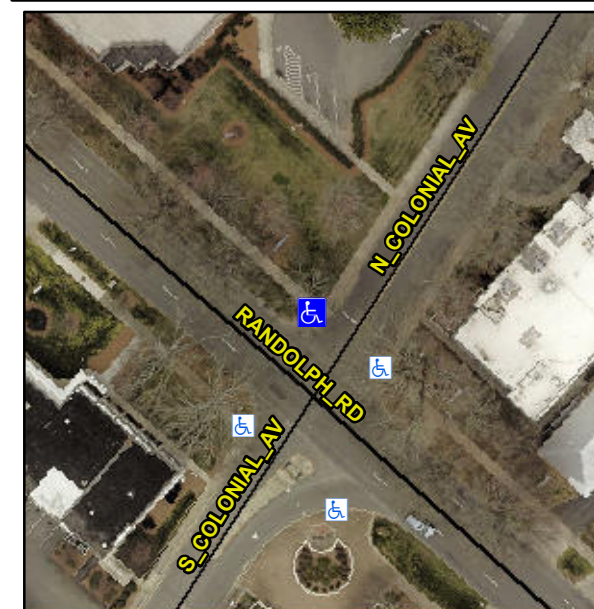
| ADA ID: 646A9508DD81 | Ramp Type: Perp | Initial Pass/Fail: Fail | Overall Compliance: No |
| Severity Score: 33.75 | | | |

**R304.5.1, R304.2.2**

| Compliance | Description | Data | Compliance | Description | Data |
|---|---|---|---|---|---|
| N/A | Ramp Length (in) | 83.0 | No | Ramp Slope (%) | 14.5 |
| No | Ramp Width (in) | 38.0 | Yes | Ramp XSlope (%) | 1.2 |

**Remove & Replace Entire Ramp.**

Total Cost: \$ 1850.00

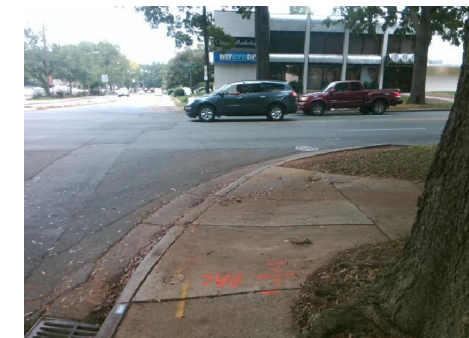
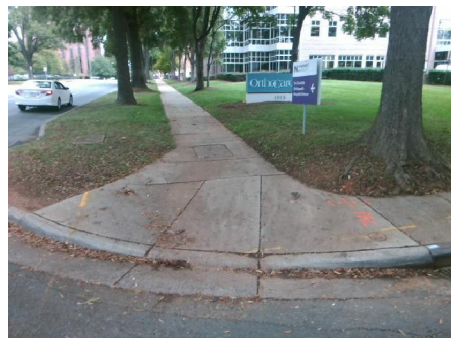
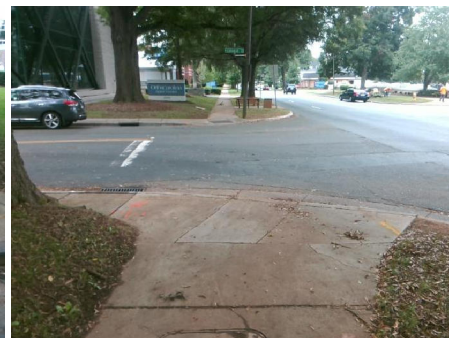
| Compliance | Description | Data | Compliance | Description | Data |
|---|---|---|---|---|---|
| | | | Yes | Surface Condition? (G/P) | Good |
