Access Compliance Report

Public Rights-of-Way

(Curb Ramps)

Intersection ID: 13531	Main Street: REMOUNT_RD	Cross Street: WEST_BV	Location: NE
ADA ID: 6470E25BEB7F	Ramp Type: PerpDiag	Initial Pass/Fail: Fail	Overall Compliance: No
		Severity Score: 50

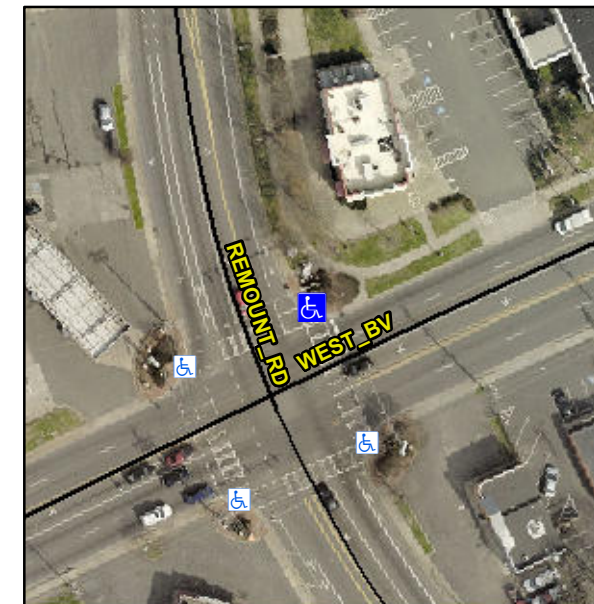
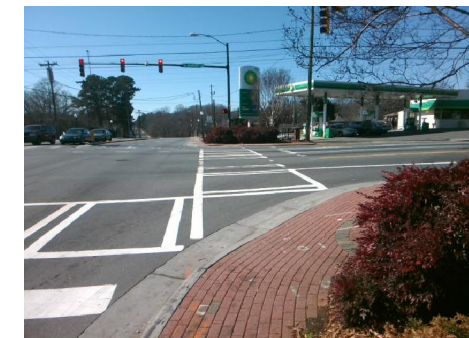
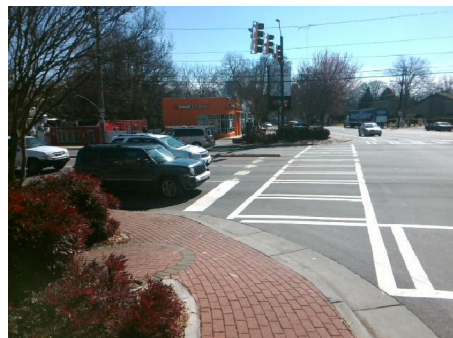
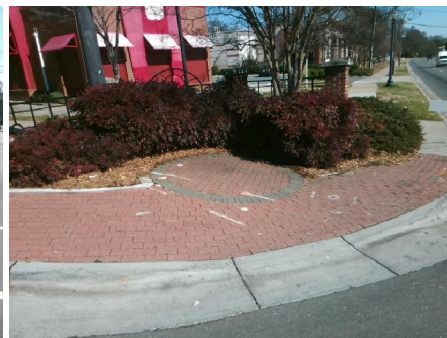
Not Found, R304.2.2, R304.5.3

Compliance	Description	Data	Compliance	Description	Data
N/A	Ramp Length (in)	67.0	No	Ramp Slope (%)	12.0
Yes	Ramp Width (in)	49.0	No	Ramp XSlope (%)	9.7
N/A	Flare Type LT	N/A	N/A	Flare Type RT	N/A
N/A	Flare Slope LT (%)	N/A	N/A	Flare Slope RT (%)	N/A
N/A	Flare Traversable LT?	N/A	N/A	Flare Traversable RT?	N/A
N/A	Landing Length (in)	N/A	N/A	DWS Provided?	N/A
N/A	Landing Width (in)	N/A	N/A	DWS Contrast?	N/A
N/A	Landing Slope (%)	N/A	N/A	DWS Length (in)	N/A
N/A	Landing X Slope (%)	N/A	N/A	DWS Full Width?	N/A
N/A	Landing Curb? (Y/N)	N/A	N/A	DWS Offset (in)	N/A
N/A	Shared Landing?	N/A			
N/A	Gutter Ponding?	N/A	N/A	Gutter Slope (%)	N/A
N/A	Gutter Lip Ht (in)	N/A	N/A	Gutter X Slope (%)	N/A
N/A	Painted X Walk1?	Yes	N/A	Painted X Walk2?	Yes
	X Walk 1 Direction	To W		X Walk 2 Direction	To S
N/A	X Walk 1 Width (in)	111.0	N/A	X Walk 2 Width (in)	110.0
	X Walk 1 Slope (%)	1.7		X Walk 2 Slope (%)	1.2
	X Walk 1 X Slope (%)	4.5		X Walk 2 X Slope (%)	3.8

N/A	Ramp inside XWalk1?	Yes	N/A	Ramp inside XWalk2?	Yes
	Road Slope (%)	6.0	N/A	Clear Space?	N/A
	Road X Slope (%)	1.3	N/A	Clear Space to XWalk (in)	N/A
N/A	Any Obstructions?	N/A	N/A	Storm Grate/Utility Hazard?	N/A
	Obstruction Type			Storm Grate/Utility Type	
		N/A			N/A
		Yes		Surface Condition? (G/P)	Good

Remove & Replace Curb Ramp With Two New Directional Ramps or Equivalent.

Total Cost: \$ 3200.00
