Access Compliance Report

Public Rights-of-Way

(Curb Ramps)

Intersection ID: 15477	Main Street: W_TYVOLA_RD	Cross Street: CASCADE_POINTE_BV	Location:	N
ADA ID: 6480D44E4FB3	Ramp Type: Perp	Initial Pass/Fail: Fail	Overall Compliance: No	Severity Score: 35
Codes/Mitigation Info/Possible Solution		Field Measurements/Component Compliance

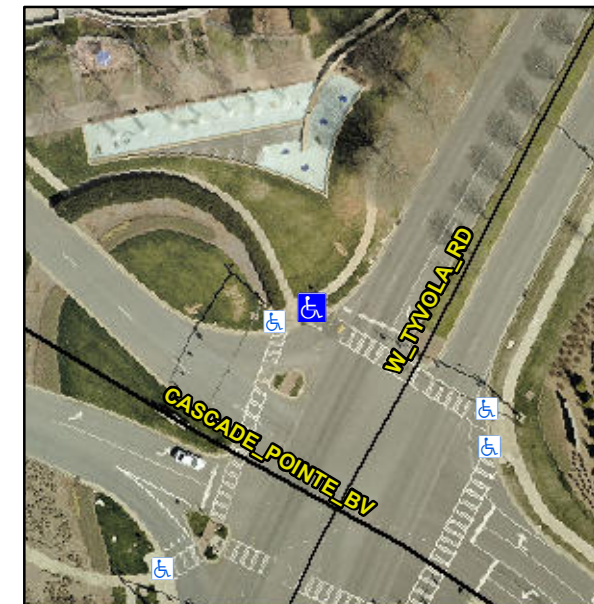
Not Found, R304.5.1, R304.2.2, R304.5.3

Compliance	Description	Data	Compliance	Description	Data
N/A	Ramp Length (in)	77.0	No	Ramp Slope (%)	15.1
No	Ramp Width (in)	41.0	No	Ramp XSlope (%)	3.3
N/A	Flare Type LT	N/A	N/A	Flare Type RT	N/A
N/A	Flare Slope LT (%)	N/A	N/A	Flare Slope RT (%)	N/A
N/A	Flare Traversable LT?	N/A	N/A	Flare Traversable RT?	N/A
N/A	Landing Length (in)	N/A	N/A	DWS Provided?	N/A
N/A	Landing Width (in)	N/A	N/A	DWS Contrast?	N/A
N/A	Landing Slope (%)	N/A	N/A	DWS Length (in)	N/A
N/A	Landing X Slope (%)	N/A	N/A	DWS Full Width?	N/A
N/A	Landing Curb? (Y/N)	N/A	N/A	DWS Offset (in)	N/A
N/A	Shared Landing?	N/A			
N/A	Gutter Ponding?	N/A	N/A	Gutter Slope (%)	N/A
N/A	Gutter Lip Ht (in)	N/A	N/A	Gutter X Slope (%)	N/A
N/A	Painted X Walk1?	Yes	N/A	Painted X Walk2?	N/A
	X Walk 1 Direction	To SW		X Walk 2 Direction	N/A
N/A	X Walk 1 Width (in)	112.0	N/A	X Walk 2 Width (in)	N/A
	X Walk 1 Slope (%)	1.3		X Walk 2 Slope (%)	N/A
	X Walk 1 X Slope (%)	2.2		X Walk 2 X Slope (%)	N/A

N/A	Ramp inside XWalk1?	Yes	N/A	Ramp inside XWalk2?	N/A
	Road Slope (%)	N/A	N/A	Clear Space?	N/A
	Road X Slope (%)	N/A	N/A	Clear Space to XWalk (in)	N/A
N/A	Any Obstructions?	N/A	N/A	Storm Grate/Utility Hazard?	N/A
	Obstruction Type			Storm Grate/Utility Type	
		N/A			N/A
			Yes	Surface Condition? (G/P)	Good

Possible Solutions:

Remove & Replace Entire Ramp.
