Access Compliance Report

Public Rights-of-Way

(Curb Ramps)

Intersection ID: 53640	Main Street: S_TRYON_ST	Cross Street: HOOVER_CREEK_BV	Location: SE
ADA ID: 648C02F74FA8	Ramp Type: PerpDiag	Initial Pass/Fail: Fail	Overall Compliance: No
Severity Score: 12.5			
Codes/Mitigation Info/Possible Solution		Field Measurements/Component Compliance

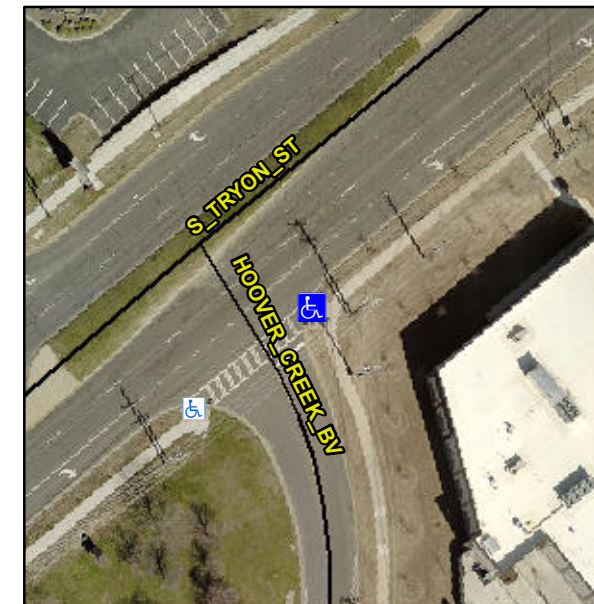
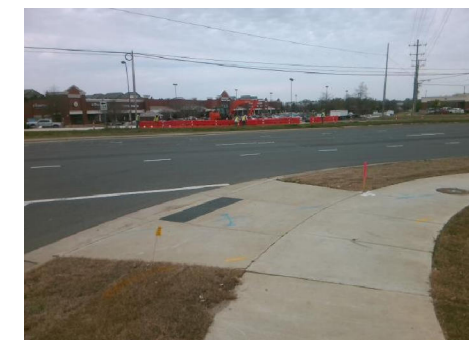
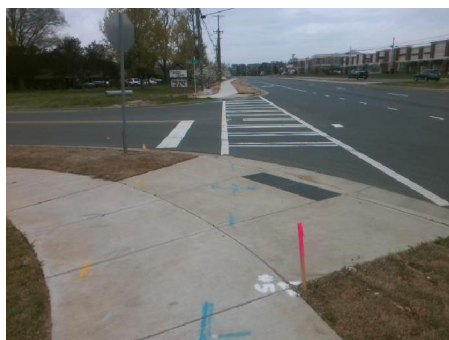
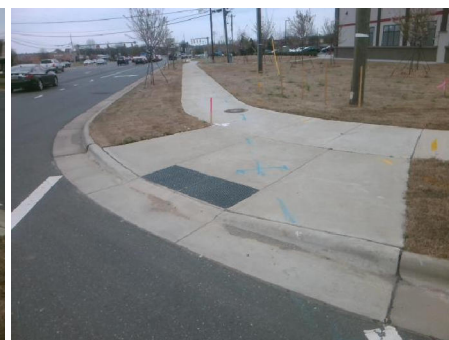
Compliance	Description	Data	Compliance	Description	Data
N/A	Ramp Length (in)	95.5	No	Ramp Slope (%)	8.7
Yes	Ramp Width (in)	61.5	Yes	Ramp XSlope (%)	0.4
N/A	Flare Type LT	N/A	N/A	Flare Type RT	N/A
N/A	Flare Slope LT (%)	N/A	N/A	Flare Slope RT (%)	N/A
N/A	Flare Traversable LT?	N/A	N/A	Flare Traversable RT?	N/A
N/A	Landing Length (in)	N/A	N/A	DWS Provided?	N/A
N/A	Landing Width (in)	N/A	N/A	DWS Contrast?	N/A
N/A	Landing Slope (%)	N/A	N/A	DWS Length (in)	N/A
N/A	Landing X Slope (%)	N/A	N/A	DWS Full Width?	N/A
N/A	Landing Curb? (Y/N)	N/A	N/A	DWS Offset (in)	N/A
N/A	Shared Landing?	N/A			
N/A	Gutter Ponding?	N/A	N/A	Gutter Slope (%)	N/A
N/A	Gutter Lip Ht (in)	N/A	N/A	Gutter X Slope (%)	N/A
N/A	Painted X Walk1?	No	N/A	Painted X Walk2?	Yes
	X Walk 1 Direction	To NW		X Walk 2 Direction	To SW
N/A	X Walk 1 Width (in)	N/A	N/A	X Walk 2 Width (in)	117.0
	X Walk 1 Slope (%)	1.2		X Walk 2 Slope (%)	0.3
	X Walk 1 X Slope (%)	0.2		X Walk 2 X Slope (%)	1.6

N/A	Ramp inside XWalk1?	N/A	N/A	Ramp inside XWalk2?	Yes
	Road Slope (%)	2.5	N/A	Clear Space?	N/A
	Road X Slope (%)	0.1	N/A	Clear Space to XWalk (in)	N/A
N/A	Any Obstructions?	N/A	N/A	Storm Grate/Utility Hazard?	N/A
	Obstruction Type			Storm Grate/Utility Type	
		N/A			N/A
			Yes	Surface Condition? (G/P)	Good

Possible Solutions:

Remove & Replace Curb Ramp With Two New Directional Ramps or Equivalent.

Not Found, R304.2.2
