# Access Compliance Report

## Public Rights-of-Way

### (Curb Ramps)

Intersection ID: 10027975	Main Street: HARLEE_AV	Cross Street: N/A	Location: N
ADA ID: 648CFF963E14	Ramp Type: PerpDiag	Initial Pass/Fail: Fail	Overall Compliance: No
Codes/Mitigation Info/Possible Solution		Field Measurements/Component Compliance

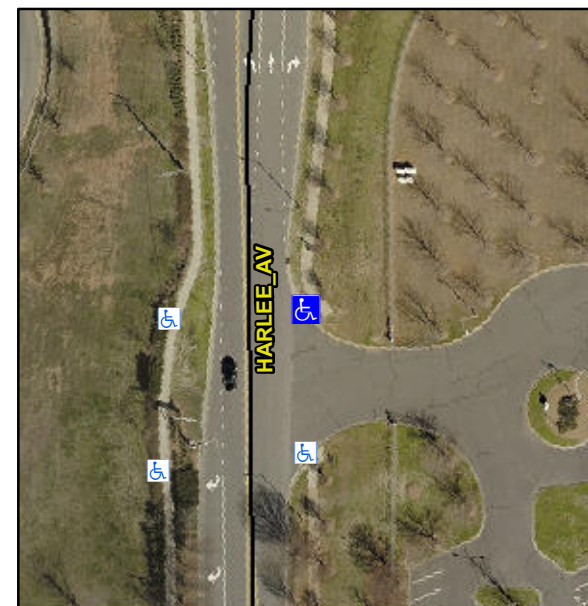
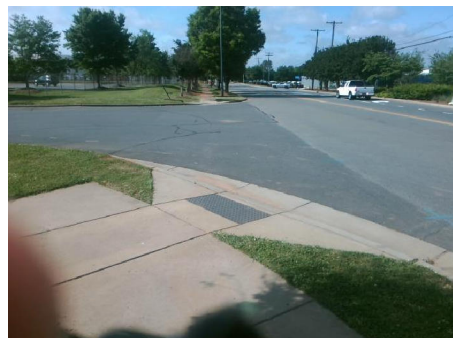
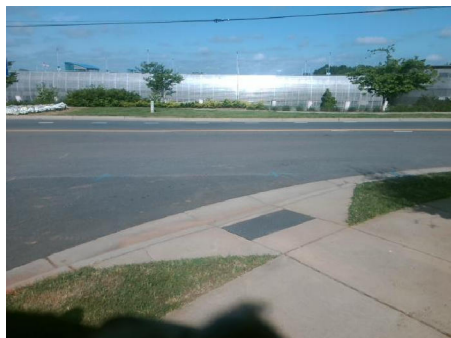
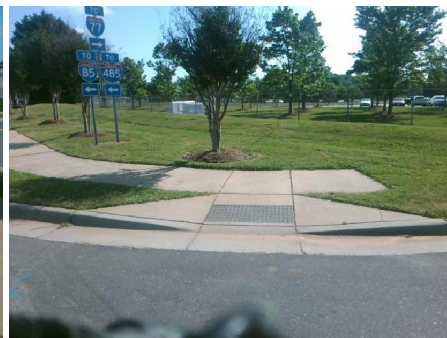
**Not Found, R304.5.1, R304.2.2**

Compliance	Description	Data	Compliance	Description	Data
N/A	Ramp Length (in)	48.0	No	Ramp Slope (%)	9.2
No	Ramp Width (in)	47.5	Yes	Ramp XSlope (%)	0.4
N/A	Flare Type LT	N/A	N/A	Flare Type RT	N/A
N/A	Flare Slope LT (%)	N/A	N/A	Flare Slope RT (%)	N/A
N/A	Flare Traversable LT?	N/A	N/A	Flare Traversable RT?	N/A
N/A	Landing Length (in)	N/A	N/A	DWS Provided?	N/A
N/A	Landing Width (in)	N/A	N/A	DWS Contrast?	N/A
N/A	Landing Slope (%)	N/A	N/A	DWS Length (in)	N/A
N/A	Landing X Slope (%)	N/A	N/A	DWS Full Width?	N/A
N/A	Landing Curb? (Y/N)	N/A	N/A	DWS Offset (in)	N/A
N/A	Shared Landing?	N/A			
N/A	Gutter Ponding?	N/A	N/A	Gutter Slope (%)	N/A
N/A	Gutter Lip Ht (in)	N/A	N/A	Gutter X Slope (%)	N/A
N/A	Painted X Walk1?	No	N/A	Painted X Walk2?	No
	X Walk 1 Direction	To W		X Walk 2 Direction	To S
N/A	X Walk 1 Width (in)	N/A	N/A	X Walk 2 Width (in)	N/A
	X Walk 1 Slope (%)	5.4		X Walk 2 Slope (%)	2.3
	X Walk 1 X Slope (%)	1.7		X Walk 2 X Slope (%)	3.1

N/A	Ramp inside XWalk1?	N/A	N/A	Ramp inside XWalk2?	N/A
	Road Slope (%)	0.8	N/A	Clear Space?	N/A
	Road X Slope (%)	1.4	N/A	Clear Space to XWalk (in)	N/A
N/A	Any Obstructions?	N/A	N/A	Storm Grate/Utility Hazard?	N/A
	Obstruction Type			Storm Grate/Utility Type	
		N/A			N/A
		Yes		Surface Condition? (G/P)	Good

**Remove & Replace Curb Ramp With Two New Directional Ramps or Equivalent.**

Total Cost: \$ **3200.00**
