# Access Compliance Report

## Public Rights-of-Way

### (Curb Ramps)

Intersection ID: 53215	Main Street: BUICK_DR	Cross Street: CONFERENCE_DR	Location: NE
ADA ID: 648E270A05B7	Ramp Type: PerpDiag	Initial Pass/Fail: Fail	Overall Compliance: No
Severity Score: 13.75			
Codes/Mitigation Info/Possible Solution		Field Measurements/Component Compliance

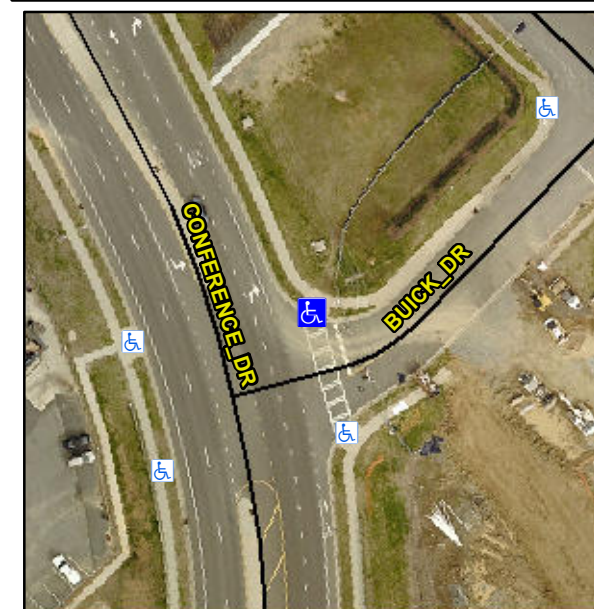
**R304.2.2, R304.5.3**

Compliance	Description	Data	Compliance	Description	Data
N/A	Ramp Length (in)	67.0	No	Ramp Slope (%)	8.8
Yes	Ramp Width (in)	48.0	No	Ramp XSlope (%)	2.9
N/A	Flare Type LT	N/A	N/A	Flare Type RT	N/A
N/A	Flare Slope LT (%)	N/A	N/A	Flare Slope RT (%)	N/A
N/A	Flare Traversable LT?	N/A	N/A	Flare Traversable RT?	N/A
N/A	Landing Length (in)	N/A	N/A	DWS Provided?	N/A
N/A	Landing Width (in)	N/A	N/A	DWS Contrast?	N/A
N/A	Landing Slope (%)	N/A	N/A	DWS Length (in)	N/A
N/A	Landing X Slope (%)	N/A	N/A	DWS Full Width?	N/A
N/A	Landing Curb? (Y/N)	N/A	N/A	DWS Offset (in)	N/A
N/A	Shared Landing?	N/A			
N/A	Gutter Ponding?	N/A	N/A	Gutter Slope (%)	N/A
N/A	Gutter Lip Ht (in)	N/A	N/A	Gutter X Slope (%)	N/A
N/A	Painted X Walk1?	No	N/A	Painted X Walk2?	Yes
	X Walk 1 Direction	To W		X Walk 2 Direction	To S
N/A	X Walk 1 Width (in)	N/A	N/A	X Walk 2 Width (in)	112.0
	X Walk 1 Slope (%)	2.1		X Walk 2 Slope (%)	1.6
	X Walk 1 X Slope (%)	0.7		X Walk 2 X Slope (%)	1.5

N/A	Ramp inside XWalk1?	N/A	N/A	Ramp inside XWalk2?	Yes
	Road Slope (%)	2.2	N/A	Clear Space?	N/A
	Road X Slope (%)	0.0	N/A	Clear Space to XWalk (in)	N/A
N/A	Any Obstructions?	N/A	N/A	Storm Grate/Utility Hazard?	N/A
	Obstruction Type			Storm Grate/Utility Type	
		N/A			N/A
			Yes	Surface Condition? (G/P)	Good

Possible Solutions:

**Remove & Replace Curb Ramp With Two New Directional Ramps or Equivalent.**

Total Cost: \$ 3200.00

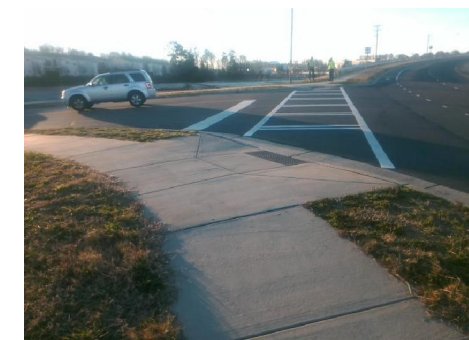
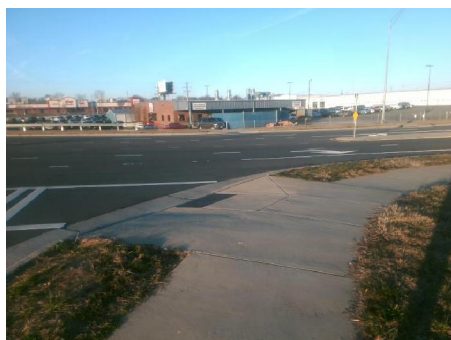
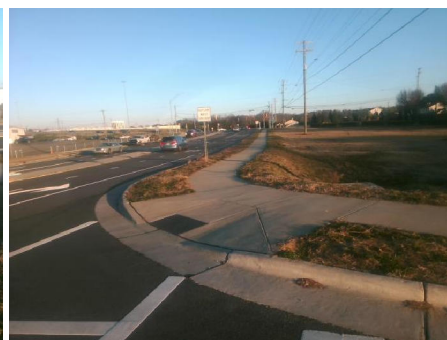
Street 1 Name CONFERENCE DR  
 Stop Condition-Street 2 None  
 Street 2 Name BUICK DR  
 Stop Condition-Street 1 StopSign
