Access Compliance Report

Public Rights-of-Way

(Curb Ramps)

Intersection ID: 12080	Main Street: E_15TH_ST	Cross Street: SEIGLE_AV	Location: S
ADA ID: 64905CF9FDDD	Ramp Type: Perp	Initial Pass/Fail: Pass	Overall Compliance: No
Severity Score: 2.5			
Codes/Mitigation Info/Possible Solution		Field Measurements/Component Compliance

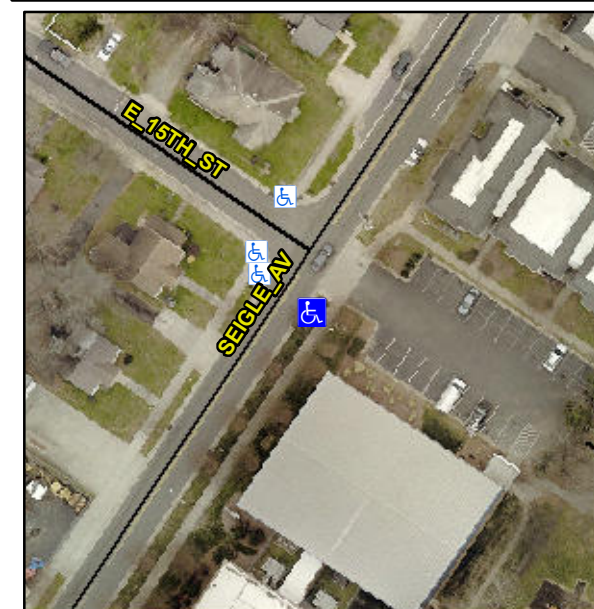
Not Found, R305.1.4

Compliance	Description	Data	Compliance	Description	Data
N/A	Ramp Length (in)	94.0	Yes	Ramp Slope (%)	5.2
Yes	Ramp Width (in)	59.5	Yes	Ramp XSlope (%)	1.3
N/A	Flare Type LT	None	N/A	Flare Type RT	N/A
N/A	Flare Slope LT (%)	N/A	N/A	Flare Slope RT (%)	N/A
N/A	Flare Traversable LT?	N/A	N/A	Flare Traversable RT?	N/A
Yes	Landing Length (in)	73.0	Yes	DWS Provided?	Yes
Yes	Landing Width (in)	58.0	Yes	DWS Contrast?	Yes
Yes	Landing Slope (%)	2.0	Yes	DWS Length (in)	24.5
Yes	Landing X Slope (%)	1.3	No	DWS Full Width?	No
N/A	Landing Curb? (Y/N)	No	Yes	DWS Offset (in)	2.0
N/A	Shared Landing?	No			
Yes	Gutter Ponding?	No	Yes	Gutter Slope (%)	1.4
Yes	Gutter Lip Ht (in)	0.0	Yes	Gutter X Slope (%)	0.9
N/A	Painted X Walk1?	No	N/A	Painted X Walk2?	N/A
	X Walk 1 Direction	To NW		X Walk 2 Direction	N/A
N/A	X Walk 1 Width (in)	N/A	N/A	X Walk 2 Width (in)	N/A
	X Walk 1 Slope (%)	2.7		X Walk 2 Slope (%)	N/A
	X Walk 1 X Slope (%)	0.6		X Walk 2 X Slope (%)	N/A

N/A	Ramp inside XWalk1?	N/A	N/A	Ramp inside XWalk2?	N/A
	Road Slope (%)	N/A	N/A	Clear Space?	Yes
	Road X Slope (%)	N/A	N/A	Clear Space to XWalk (in)	N/A
Yes	Any Obstructions?	No	Yes	Storm Grate/Utility Hazard?	No
	Obstruction Type			Storm Grate/Utility Type	
		N/A			N/A
			Yes	Surface Condition? (G/P)	Good

Possible Solutions:

Remove & Replace Entire Ramp.
