Access Compliance Report

Public Rights-of-Way

(Curb Ramps)

Intersection ID: 11650	Main Street: W_10TH_ST	Cross Street: N_CHURCH_ST	Location: W
ADA ID: 64A1F49183E7	Ramp Type: PerpDiag	Initial Pass/Fail: Fail	Overall Compliance: No
Severity Score: 33.75			
Codes/Mitigation Info/Possible Solution		Field Measurements/Component Compliance

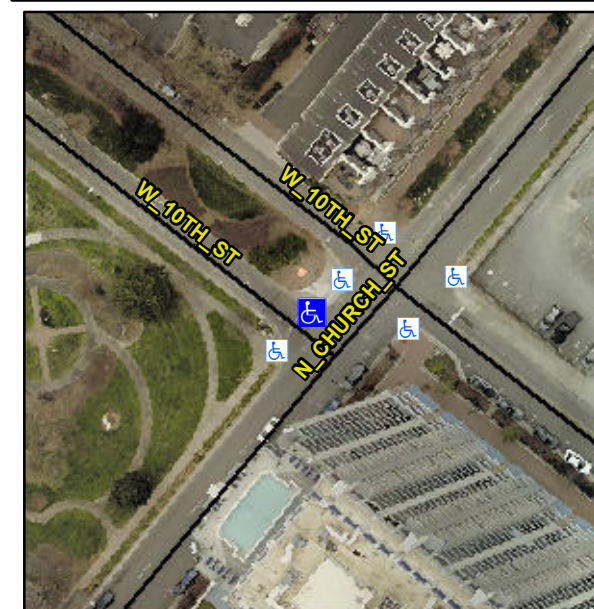
Not Found, R304.5.1, R304.5.3

Compliance	Description	Data	Compliance	Description	Data
N/A	Ramp Length (in)	64.0	Yes	Ramp Slope (%)	5.3
No	Ramp Width (in)	38.0	No	Ramp XSlope (%)	9.1
N/A	Flare Type LT	N/A	N/A	Flare Type RT	N/A
N/A	Flare Slope LT (%)	N/A	N/A	Flare Slope RT (%)	N/A
N/A	Flare Traversable LT?	N/A	N/A	Flare Traversable RT?	N/A
N/A	Landing Length (in)	N/A	N/A	DWS Provided?	N/A
N/A	Landing Width (in)	N/A	N/A	DWS Contrast?	N/A
N/A	Landing Slope (%)	N/A	N/A	DWS Length (in)	N/A
N/A	Landing X Slope (%)	N/A	N/A	DWS Full Width?	N/A
N/A	Landing Curb? (Y/N)	N/A	N/A	DWS Offset (in)	N/A
N/A	Shared Landing?	N/A			
N/A	Gutter Ponding?	N/A	N/A	Gutter Slope (%)	N/A
N/A	Gutter Lip Ht (in)	N/A	N/A	Gutter X Slope (%)	N/A
N/A	Painted X Walk1?	No	N/A	Painted X Walk2?	No
	X Walk 1 Direction	To SW		X Walk 2 Direction	To SE
N/A	X Walk 1 Width (in)	N/A	N/A	X Walk 2 Width (in)	N/A
	X Walk 1 Slope (%)	0.7		X Walk 2 Slope (%)	0.7
	X Walk 1 X Slope (%)	1.3		X Walk 2 X Slope (%)	1.2

N/A	Ramp inside XWalk1?	N/A	N/A	Ramp inside XWalk2?	N/A
	Road Slope (%)	0.7	N/A	Clear Space?	N/A
	Road X Slope (%)	2.3	N/A	Clear Space to XWalk (in)	N/A
N/A	Any Obstructions?	N/A	N/A	Storm Grate/Utility Hazard?	N/A
	Obstruction Type			Storm Grate/Utility Type	
		N/A			N/A
			Yes	Surface Condition? (G/P)	Good

Remove & Replace Curb Ramp With Two New Directional Ramps or Equivalent.
