Access Compliance Report

Public Rights-of-Way

(Curb Ramps)

Intersection ID: 12244	Main Street: BELMONT_AV	Cross Street: HARRILL_ST	Location: W
ADA ID: 64A2D3BD41B4	Ramp Type: Perp	Initial Pass/Fail: Fail	Overall Compliance: No
		Severity Score: 8.75

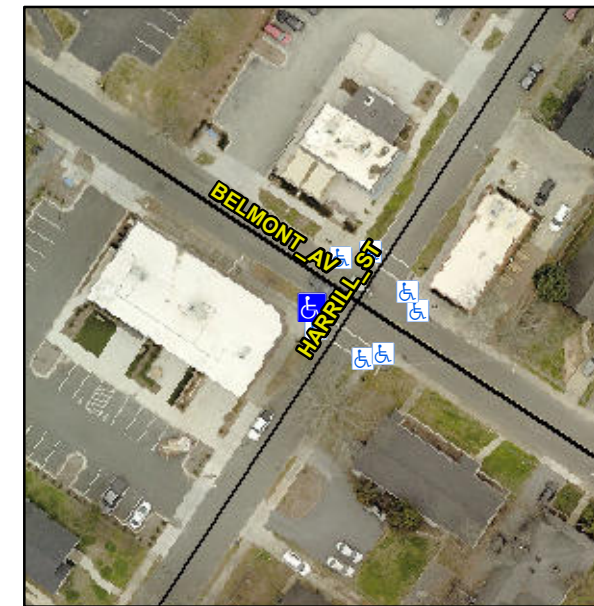
Not Found, R304.5.1

Compliance	Description	Data	Compliance	Description	Data
N/A	Ramp Length (in)	87.5	Yes	Ramp Slope (%)	7.4
No	Ramp Width (in)	47.5	Yes	Ramp XSlope (%)	0.2
N/A	Flare Type LT	N/A	N/A	Flare Type RT	N/A
N/A	Flare Slope LT (%)	N/A	N/A	Flare Slope RT (%)	N/A
N/A	Flare Traversable LT?	N/A	N/A	Flare Traversable RT?	N/A
N/A	Landing Length (in)	N/A	N/A	DWS Provided?	N/A
N/A	Landing Width (in)	N/A	N/A	DWS Contrast?	N/A
N/A	Landing Slope (%)	N/A	N/A	DWS Length (in)	N/A
N/A	Landing X Slope (%)	N/A	N/A	DWS Full Width?	N/A
N/A	Landing Curb? (Y/N)	N/A	N/A	DWS Offset (in)	N/A
N/A	Shared Landing?	N/A			
N/A	Gutter Ponding?	N/A	N/A	Gutter Slope (%)	N/A
N/A	Gutter Lip Ht (in)	N/A	N/A	Gutter X Slope (%)	N/A
N/A	Painted X Walk1?	No	N/A	Painted X Walk2?	N/A
	X Walk 1 Direction	To NE		X Walk 2 Direction	N/A
N/A	X Walk 1 Width (in)	N/A	N/A	X Walk 2 Width (in)	N/A
	X Walk 1 Slope (%)	4.3		X Walk 2 Slope (%)	N/A
	X Walk 1 X Slope (%)	2.9		X Walk 2 X Slope (%)	N/A

Remove & Replace Entire Ramp.
