Access Compliance Report

Public Rights-of-Way

(Curb Ramps)

Intersection ID: 50272	Main Street: SOUTH_BV	Cross Street: WHITTON_ST	Location: SW
ADA ID: 64A62C24972F	Ramp Type: Perp	Initial Pass/Fail: Fail	Overall Compliance: No
			Severity Score: 13.75

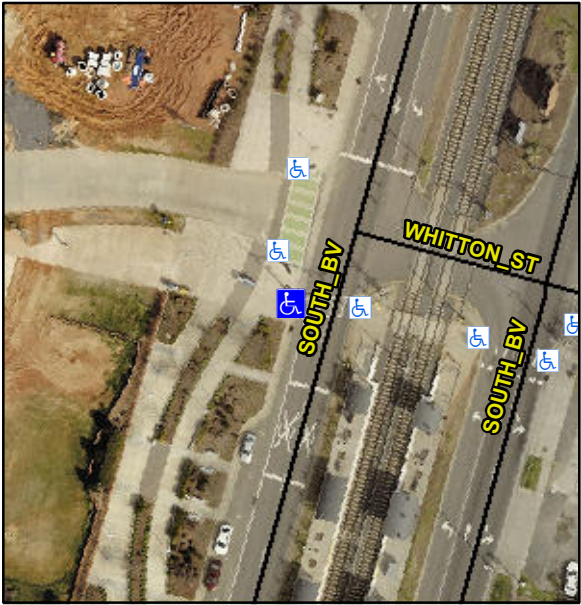
Possible Solutions:		Compliance	Description	Data
	Remove & Replace Entire Ramp.		N/A	Ramp Length (in)	75.0
			Yes	Ramp Width (in)	48.0
			N/A	Flare Type LT	N/A
			N/A	Flare Slope LT (%)	N/A
			N/A	Flare Traversable LT?	N/A
			N/A	Landing Length (in)	N/A
			N/A	Landing Width (in)	N/A
			N/A	Landing Slope (%)	N/A
			N/A	Landing X Slope (%)	N/A
<p>Surveyor Notes:</p> <p>N/A</p> <p>PROW/ADA:</p> <p>Not Found, R304.2.2, R304.5.3</p>			N/A	Flare Type RT	N/A
			N/A	Flare Slope RT (%)	N/A
			N/A	Flare Traversable RT?	N/A
			N/A	DWS Provided?	N/A
			N/A	DWS Contrast?	N/A
			N/A	DWS Length (in)	N/A
			N/A	DWS Full Width?	N/A
			N/A	DWS Offset (in)	N/A
			N/A	Shared Landing?	N/A
			N/A	Gutter Ponding?	N/A
			N/A	Gutter Lip Ht (in)	N/A
			N/A	Painted X Walk1?	Yes
				X Walk 1 Direction	To E
			N/A	X Walk 1 Width (in)	110.0
				X Walk 1 Slope (%)	0.3

X Walk 1 X Slope (%)	0.8
			N/A	Ramp inside XWalk1?	Yes
				Road Slope (%)	N/A
				Road X Slope (%)	N/A
			N/A	Any Obstructions?	N/A
				Obstruction Type	
Total Cost:		\$ 1850.00			
			N/A		N/A
			Yes	Surface Condition? (G/P)	Good
