Access Compliance Report

Public Rights-of-Way

(Curb Ramps)

Intersection ID: 50636	Main Street: BLUE_GROVE_RD	Cross Street: RED_WATER_RD	Location: SW
ADA ID: 64AF7A655216	Ramp Type: Perp	Initial Pass/Fail: Fail	Overall Compliance: No
Severity Score: 21.25			
Codes/Mitigation Info/Possible Solution		Field Measurements/Component Compliance

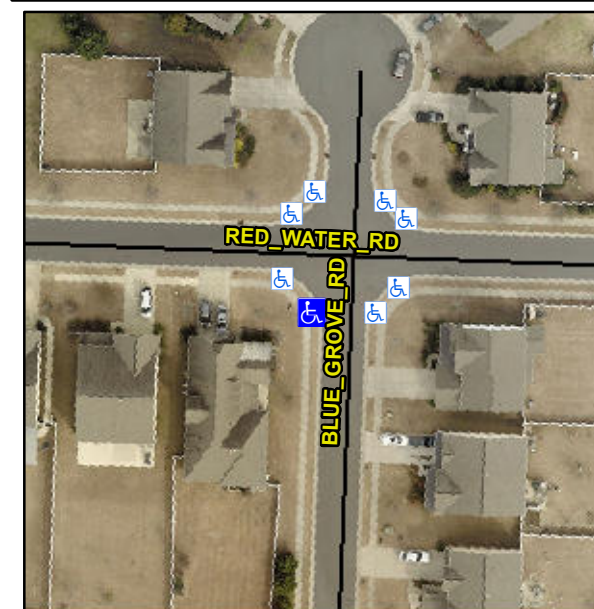
Not Found, R304.5.1, R304.5.3

Compliance	Description	Data	Compliance	Description	Data
N/A	Ramp Length (in)	47.0	Yes	Ramp Slope (%)	7.0
No	Ramp Width (in)	47.0	No	Ramp XSlope (%)	5.5
N/A	Flare Type LT	N/A	N/A	Flare Type RT	N/A
N/A	Flare Slope LT (%)	N/A	N/A	Flare Slope RT (%)	N/A
N/A	Flare Traversable LT?	N/A	N/A	Flare Traversable RT?	N/A
N/A	Landing Length (in)	N/A	N/A	DWS Provided?	N/A
N/A	Landing Width (in)	N/A	N/A	DWS Contrast?	N/A
N/A	Landing Slope (%)	N/A	N/A	DWS Length (in)	N/A
N/A	Landing X Slope (%)	N/A	N/A	DWS Full Width?	N/A
N/A	Landing Curb? (Y/N)	N/A	N/A	DWS Offset (in)	N/A
N/A	Shared Landing?	N/A			
N/A	Gutter Ponding?	N/A	N/A	Gutter Slope (%)	N/A
N/A	Gutter Lip Ht (in)	N/A	N/A	Gutter X Slope (%)	N/A
N/A	Painted X Walk1?	No	N/A	Painted X Walk2?	N/A
	X Walk 1 Direction	To SE		X Walk 2 Direction	N/A
N/A	X Walk 1 Width (in)	N/A	N/A	X Walk 2 Width (in)	N/A
	X Walk 1 Slope (%)	2.4		X Walk 2 Slope (%)	N/A
	X Walk 1 X Slope (%)	5.6		X Walk 2 X Slope (%)	N/A

N/A	Ramp inside XWalk1?	N/A	N/A	Ramp inside XWalk2?	N/A
	Road Slope (%)	N/A	N/A	Clear Space?	N/A
	Road X Slope (%)	N/A	N/A	Clear Space to XWalk (in)	N/A
N/A	Any Obstructions?	N/A	N/A	Storm Grate/Utility Hazard?	N/A
	Obstruction Type			Storm Grate/Utility Type	
		N/A			N/A
			Yes	Surface Condition? (G/P)	Good

Possible Solutions:

Remove & Replace Entire Ramp.
