Access Compliance Report

Public Rights-of-Way

(Curb Ramps)

Intersection ID: 16141	Main Street: WENDOVER_RD	Cross Street: LATROBE_DR	Location: S
ADA ID: 64B333E006F4	Ramp Type: Perp	Initial Pass/Fail: Fail	Overall Compliance: No
Severity Score: 25			
Codes/Mitigation Info/Possible Solution		Field Measurements/Component Compliance

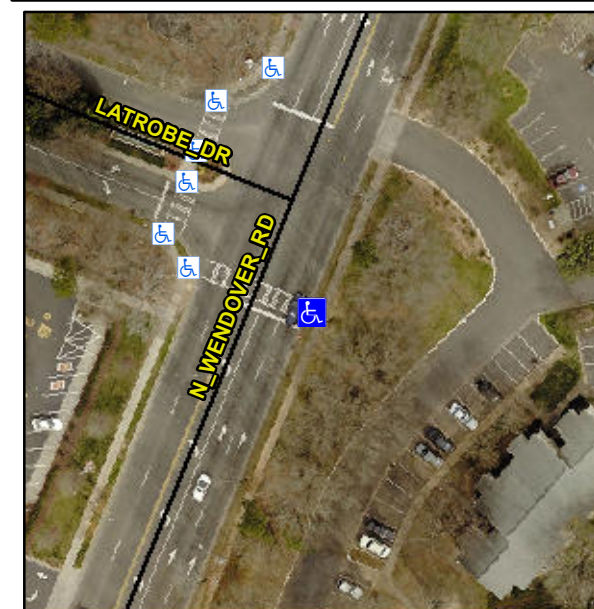
Not Found, R304.2.2

Compliance	Description	Data	Compliance	Description	Data
N/A	Ramp Length (in)	53.0	No	Ramp Slope (%)	16.8
Yes	Ramp Width (in)	48.0	Yes	Ramp XSlope (%)	1.6
N/A	Flare Type LT	N/A	N/A	Flare Type RT	N/A
N/A	Flare Slope LT (%)	N/A	N/A	Flare Slope RT (%)	N/A
N/A	Flare Traversable LT?	N/A	N/A	Flare Traversable RT?	N/A
N/A	Landing Length (in)	N/A	N/A	DWS Provided?	N/A
N/A	Landing Width (in)	N/A	N/A	DWS Contrast?	N/A
N/A	Landing Slope (%)	N/A	N/A	DWS Length (in)	N/A
N/A	Landing X Slope (%)	N/A	N/A	DWS Full Width?	N/A
N/A	Landing Curb? (Y/N)	N/A	N/A	DWS Offset (in)	N/A
N/A	Shared Landing?	N/A			
N/A	Gutter Ponding?	N/A	N/A	Gutter Slope (%)	N/A
N/A	Gutter Lip Ht (in)	N/A	N/A	Gutter X Slope (%)	N/A
N/A	Painted X Walk1?	Yes	N/A	Painted X Walk2?	N/A
	X Walk 1 Direction	To NW		X Walk 2 Direction	N/A
N/A	X Walk 1 Width (in)	104.0	N/A	X Walk 2 Width (in)	N/A
	X Walk 1 Slope (%)	2.9		X Walk 2 Slope (%)	N/A
	X Walk 1 X Slope (%)	1.1		X Walk 2 X Slope (%)	N/A

Remove & Replace Entire Ramp.
