Access Compliance Report

Public Rights-of-Way

(Curb Ramps)

Intersection ID: 10040846	Main Street: WAKEFIELD_DR	Cross Street: N/A	Location: NE
ADA ID: 64B52E6F3773	Ramp Type: Perp	Initial Pass/Fail: Pass	Overall Compliance: No
Codes/Mitigation Info/Possible Solution		Field Measurements/Component Compliance	
		Severity Score: 10

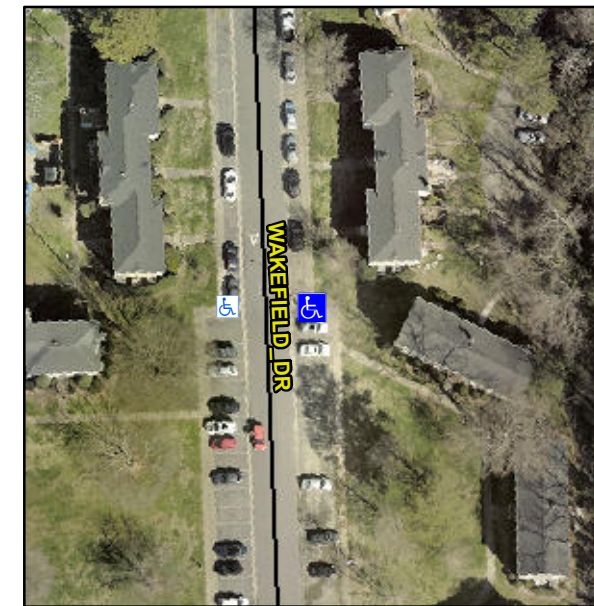
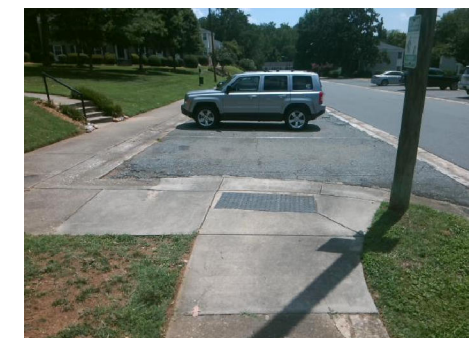
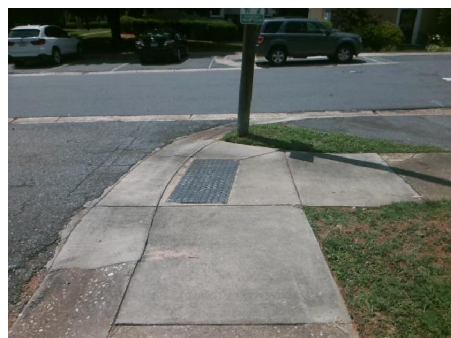
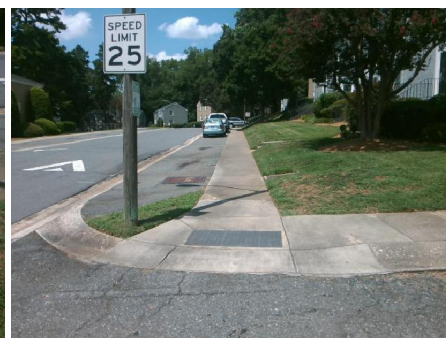
Compliance	Description	Data	Compliance	Description	Data
N/A	Ramp Length (in)	51.0	Yes	Ramp Slope (%)	5.3
Yes	Ramp Width (in)	50.0	Yes	Ramp XSlope (%)	1.9
N/A	Flare Type LT	Sloped	N/A	Flare Type RT	N/A
N/A	Flare Slope LT (%)	1.9	Yes	Flare Slope RT (%)	4.8
N/A	Flare Traversable LT?	Yes	N/A	Flare Traversable RT?	Yes
No	Landing Length (in)	46.0	Yes	DWS Provided?	Yes
Yes	Landing Width (in)	54.0	Yes	DWS Contrast?	Yes
No	Landing Slope (%)	6.2	Yes	DWS Length (in)	24.0
Yes	Landing X Slope (%)	0.5	No	DWS Full Width?	No
N/A	Landing Curb? (Y/N)	No	No	DWS Offset (in)	4.0
N/A	Shared Landing?	No			
Yes	Gutter Ponding?	No	Yes	Gutter Slope (%)	4.7
No	Gutter Lip Ht (in)	0.5	Yes	Gutter X Slope (%)	2.7
N/A	Painted X Walk1?	No	N/A	Painted X Walk2?	N/A
	X Walk 1 Direction	To S		X Walk 2 Direction	N/A
N/A	X Walk 1 Width (in)	N/A	N/A	X Walk 2 Width (in)	N/A
	X Walk 1 Slope (%)	6.9		X Walk 2 Slope (%)	N/A
	X Walk 1 X Slope (%)	2.9		X Walk 2 X Slope (%)	N/A

N/A	Ramp inside XWalk1?	N/A	N/A	Ramp inside XWalk2?	N/A
	Road Slope (%)	N/A	N/A	Clear Space?	Yes
	Road X Slope (%)	N/A	N/A	Clear Space to XWalk (in)	N/A
Yes	Any Obstructions?	No	Yes	Storm Grate/Utility Hazard?	No
	Obstruction Type			Storm Grate/Utility Type	
		N/A			N/A
			Yes	Surface Condition? (G/P)	Good

Possible Solutions:

**Remove & Replace Entire Ramp.
Grind Gutter Lip.**
