# Access Compliance Report

## Public Rights-of-Way

### (Curb Ramps)

Intersection ID: N/A	Main Street: MORABLIN_DR	Cross Street: DURANT_BV	Location: NW
ADA ID: 64CFBF09565F	Ramp Type: PerpDiag	Initial Pass/Fail: Fail	Overall Compliance: No
Severity Score: 46.25			
Codes/Mitigation Info/Possible Solution		Field Measurements/Component Compliance

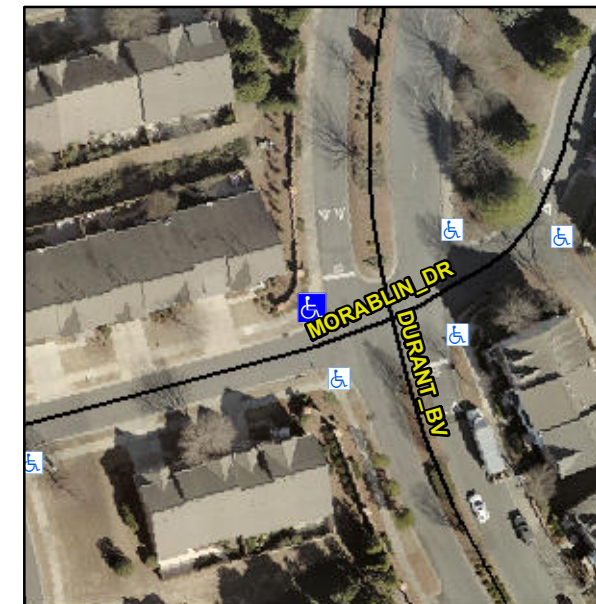
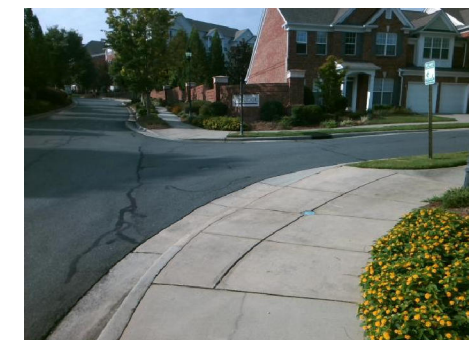
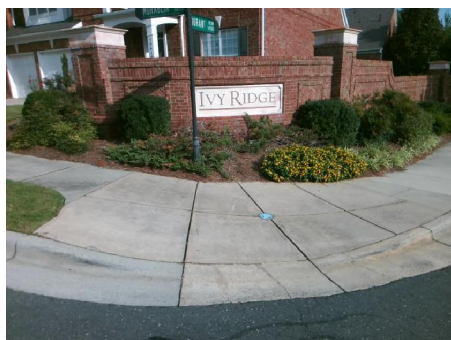
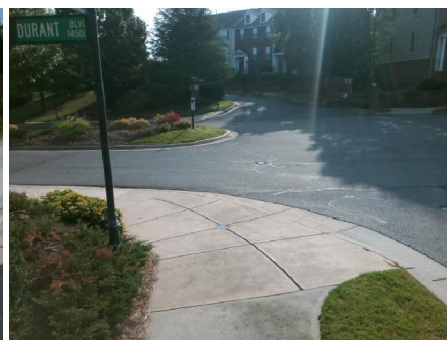
**Not Found, R304.5.1, R304.2.2, R304.5.3**

Compliance	Description	Data	Compliance	Description	Data
N/A	Ramp Length (in)	47.0	No	Ramp Slope (%)	8.6
No	Ramp Width (in)	42.0	No	Ramp XSlope (%)	13.3
N/A	Flare Type LT	N/A	N/A	Flare Type RT	N/A
N/A	Flare Slope LT (%)	N/A	N/A	Flare Slope RT (%)	N/A
N/A	Flare Traversable LT?	N/A	N/A	Flare Traversable RT?	N/A
N/A	Landing Length (in)	N/A	N/A	DWS Provided?	N/A
N/A	Landing Width (in)	N/A	N/A	DWS Contrast?	N/A
N/A	Landing Slope (%)	N/A	N/A	DWS Length (in)	N/A
N/A	Landing X Slope (%)	N/A	N/A	DWS Full Width?	N/A
N/A	Landing Curb? (Y/N)	N/A	N/A	DWS Offset (in)	N/A
N/A	Shared Landing?	N/A			
N/A	Gutter Ponding?	N/A	N/A	Gutter Slope (%)	N/A
N/A	Gutter Lip Ht (in)	N/A	N/A	Gutter X Slope (%)	N/A
N/A	Painted X Walk1?	No	N/A	Painted X Walk2?	No
	X Walk 1 Direction	To S		X Walk 2 Direction	To NE
N/A	X Walk 1 Width (in)	N/A	N/A	X Walk 2 Width (in)	N/A
	X Walk 1 Slope (%)	4.6		X Walk 2 Slope (%)	7.9
	X Walk 1 X Slope (%)	5.3		X Walk 2 X Slope (%)	6.0

N/A	Ramp inside XWalk1?	N/A	N/A	Ramp inside XWalk2?	N/A
	Road Slope (%)	8.2	N/A	Clear Space?	N/A
	Road X Slope (%)	0.8	N/A	Clear Space to XWalk (in)	N/A
N/A	Any Obstructions?	N/A	N/A	Storm Grate/Utility Hazard?	N/A
	Obstruction Type			Storm Grate/Utility Type	
		N/A			N/A
			Yes	Surface Condition? (G/P)	Good

**Remove & Replace Curb Ramp With Two New Directional Ramps or Equivalent.**

Total Cost: \$ 3200.00
