Access Compliance Report

Public Rights-of-Way

(Curb Ramps)

Intersection ID: 47312	Main Street: S_DAVIDSON_ST	Cross Street: E_STONEWALL_ST	Location: W
ADA ID: 64D6EBFF5302	Ramp Type: BlendTrans1	Initial Pass/Fail: Fail	Overall Compliance: No
		Severity Score: 8.75

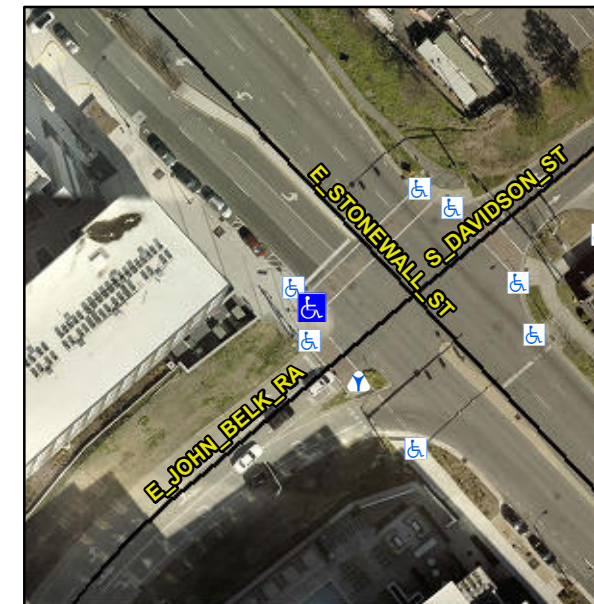
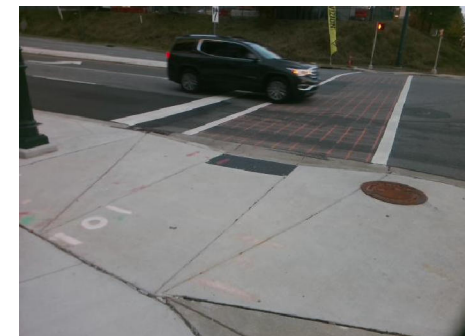
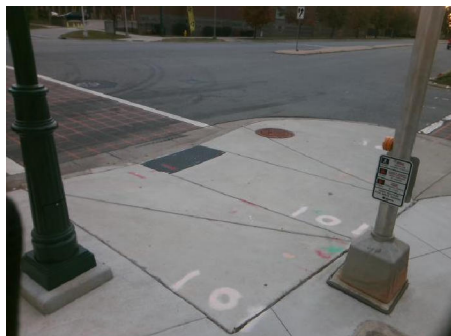
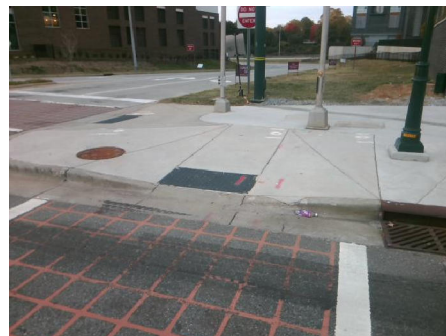
Not Found, R304.5.1

Compliance	Description	Data	Compliance	Description	Data
N/A	Ramp Length (in)	126.0	Yes	BlendTrans Slope (%)	3.7
No	Ramp Width (in)	44.0	Yes	BlendTrans XSlope (%)	0.8
N/A	Flare Type LT	N/A	N/A	Flare Type RT	N/A
N/A	Flare Slope LT (%)	N/A	N/A	Flare Slope RT (%)	N/A
N/A	Flare Traversable LT?	No	N/A	Flare Traversable RT?	No
N/A	Landing Length (in)	N/A	N/A	DWS Provided?	N/A
N/A	Landing Width (in)	N/A	N/A	DWS Contrast?	N/A
N/A	Landing Slope (%)	N/A	N/A	DWS Length (in)	N/A
N/A	Landing X Slope (%)	N/A	N/A	DWS Full Width?	N/A
N/A	Landing Curb? (Y/N)	N/A	N/A	DWS Offset (in)	N/A
N/A	Shared Landing?	N/A			
N/A	Gutter Ponding?	N/A	N/A	Gutter Slope (%)	N/A
N/A	Gutter Lip Ht (in)	N/A	N/A	Gutter X Slope (%)	N/A
N/A	Painted X Walk1?	Yes	N/A	Painted X Walk2?	N/A
	X Walk 1 Direction	To NE		X Walk 2 Direction	N/A
	X Walk 1 Width (in)	125.0		X Walk 2 Width (in)	N/A
	X Walk 1 Slope (%)	1.0		X Walk 2 Slope (%)	N/A
	X Walk 1 X Slope (%)	0.6		X Walk 2 X Slope (%)	N/A

N/A	Ramp inside XWalk1?	Yes	N/A	Ramp inside XWalk2?	N/A
	Road Slope (%)	0.6		Clear Space?	N/A
	Road X Slope (%)	1.0	N/A	Clear Space to XWalk (in)	N/A
N/A	Any Obstructions?	N/A	N/A	Storm Grate/Utility Hazard?	N/A
	Obstruction Type			Storm Grate/Utility Type	
		N/A			N/A
			Yes	Surface Condition? (G/P)	Good
			No	Curb Slope (%)	8.2

Remove & Replace Curb Ramp With Two New Directional Ramps or Equivalent.
