Access Compliance Report

Public Rights-of-Way

(Curb Ramps)

Intersection ID: 48584	Main Street: TREEFROG_CT	Cross Street: WATERLILY_LN	Location:	N
ADA ID: 64DE2874D5C6	Ramp Type: PerpDiag	Initial Pass/Fail: Fail	Overall Compliance: No	Severity Score: 21.25
Codes/Mitigation Info/Possible Solution		Field Measurements/Component Compliance

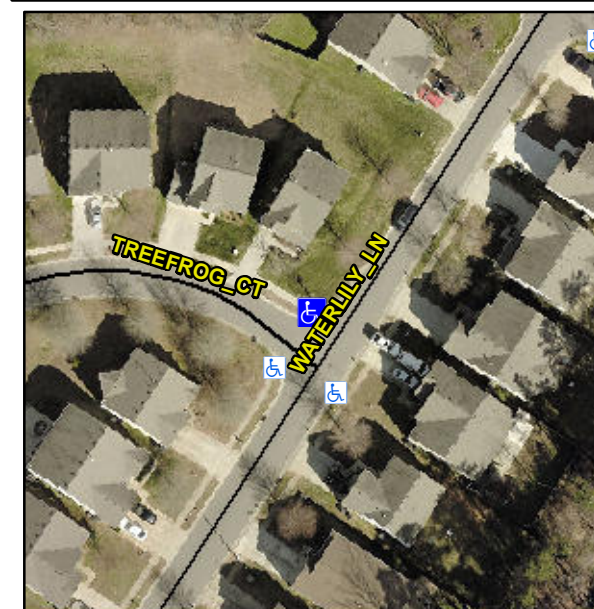
Compliance	Description	Data	Compliance	Description	Data
N/A	Ramp Length (in)	46.0	No	Ramp Slope (%)	9.0
No	Ramp Width (in)	40.0	Yes	Ramp XSlope (%)	0.6
N/A	Flare Type LT	N/A	N/A	Flare Type RT	N/A
N/A	Flare Slope LT (%)	N/A	N/A	Flare Slope RT (%)	N/A
N/A	Flare Traversable LT?	N/A	N/A	Flare Traversable RT?	N/A
N/A	Landing Length (in)	N/A	N/A	DWS Provided?	N/A
N/A	Landing Width (in)	N/A	N/A	DWS Contrast?	N/A
N/A	Landing Slope (%)	N/A	N/A	DWS Length (in)	N/A
N/A	Landing X Slope (%)	N/A	N/A	DWS Full Width?	N/A
N/A	Landing Curb? (Y/N)	N/A	N/A	DWS Offset (in)	N/A
N/A	Shared Landing?	N/A			
N/A	Gutter Ponding?	N/A	N/A	Gutter Slope (%)	N/A
N/A	Gutter Lip Ht (in)	0.75	N/A	Gutter X Slope (%)	N/A
N/A	Painted X Walk1?	No	N/A	Painted X Walk2?	No
	X Walk 1 Direction	To SW		X Walk 2 Direction	To SE
N/A	X Walk 1 Width (in)	N/A	N/A	X Walk 2 Width (in)	N/A
	X Walk 1 Slope (%)	5.9		X Walk 2 Slope (%)	2.6
	X Walk 1 X Slope (%)	1.9		X Walk 2 X Slope (%)	4.0

N/A	Ramp inside XWalk1?	N/A	N/A	Ramp inside XWalk2?	N/A
	Road Slope (%)	1.0	N/A	Clear Space?	N/A
	Road X Slope (%)	5.7	N/A	Clear Space to XWalk (in)	N/A
N/A	Any Obstructions?	N/A	N/A	Storm Grate/Utility Hazard?	N/A
	Obstruction Type			Storm Grate/Utility Type	
		N/A			N/A
			Yes	Surface Condition? (G/P)	Good

Possible Solutions:

Remove & Replace Curb Ramp With Two New Directional Ramps or Equivalent.

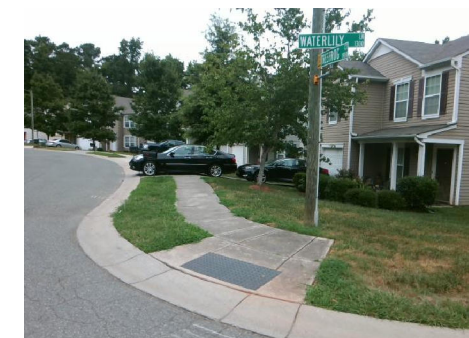
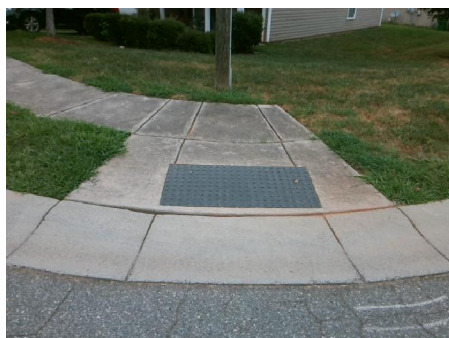
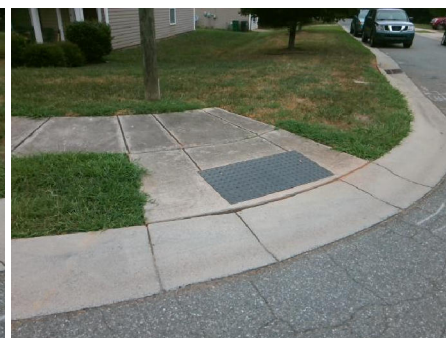
Street 1 Name TREEFROG CT
 Stop Condition-Street 2 StopSign
 Street 2 Name WATERLILY LN
 Stop Condition-Street 1 None
