# Access Compliance Report

## Public Rights-of-Way

### (Curb Ramps)

Intersection ID: 28155	Main Street: WAYLAND_DR	Cross Street: ROBSART_CT	Location: SW
ADA ID: 64DECB64A66B	Ramp Type: PerpDiag	Initial Pass/Fail: Fail	Overall Compliance: No
		Severity Score: 12.5

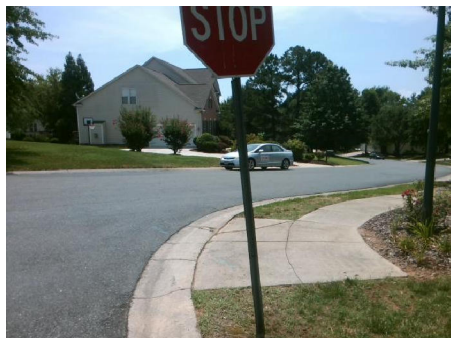
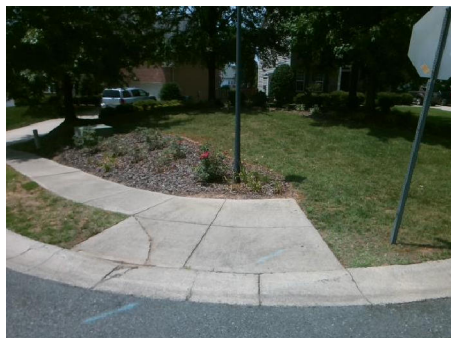
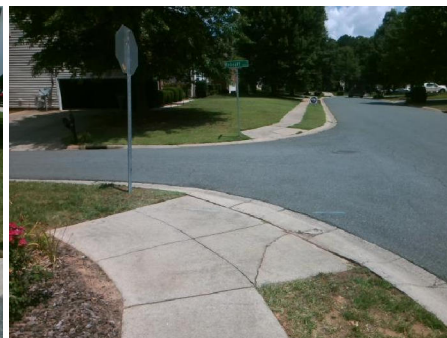
**Not Found, R304.2.2**

Compliance	Description	Data	Compliance	Description	Data
N/A	Ramp Length (in)	57.0	No	Ramp Slope (%)	8.9
Yes	Ramp Width (in)	48.0	Yes	Ramp XSlope (%)	1.2
N/A	Flare Type LT	N/A	N/A	Flare Type RT	N/A
N/A	Flare Slope LT (%)	N/A	N/A	Flare Slope RT (%)	N/A
N/A	Flare Traversable LT?	N/A	N/A	Flare Traversable RT?	N/A
N/A	Landing Length (in)	N/A	N/A	DWS Provided?	N/A
N/A	Landing Width (in)	N/A	N/A	DWS Contrast?	N/A
N/A	Landing Slope (%)	N/A	N/A	DWS Length (in)	N/A
N/A	Landing X Slope (%)	N/A	N/A	DWS Full Width?	N/A
N/A	Landing Curb? (Y/N)	N/A	N/A	DWS Offset (in)	N/A
N/A	Shared Landing?	N/A			
N/A	Gutter Ponding?	N/A	N/A	Gutter Slope (%)	N/A
N/A	Gutter Lip Ht (in)	N/A	N/A	Gutter X Slope (%)	N/A
N/A	Painted X Walk1?	No	N/A	Painted X Walk2?	No
	X Walk 1 Direction	To E		X Walk 2 Direction	To N
N/A	X Walk 1 Width (in)	N/A	N/A	X Walk 2 Width (in)	N/A
	X Walk 1 Slope (%)	2.4		X Walk 2 Slope (%)	5.6
	X Walk 1 X Slope (%)	5.7		X Walk 2 X Slope (%)	2.9

N/A	Ramp inside XWalk1?	N/A	N/A	Ramp inside XWalk2?	N/A
	Road Slope (%)	1.5	N/A	Clear Space?	N/A
	Road X Slope (%)	5.3	N/A	Clear Space to XWalk (in)	N/A
N/A	Any Obstructions?	N/A	N/A	Storm Grate/Utility Hazard?	N/A
	Obstruction Type			Storm Grate/Utility Type	
		N/A			N/A
			Yes	Surface Condition? (G/P)	Good

**Remove & Replace Curb Ramp With Two New Directional Ramps or Equivalent.**
