Access Compliance Report Public Rights-of-Way (Curb Ramps)

Intersection ID: 19525 Main Street: COLONY_RD Cross Street: ROXBOROUGH_RD Location: SW

ADA ID: 64DFE636DDE2 Ramp Type: PerpDiag Initial Pass/Fail: Fail Overall Compliance: No Severity Score: 12.5

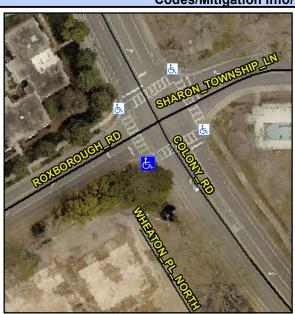
Not Found, R304.2.2

| Field Measurements/Component Compliance | | | | | | |
|---|---|---|---|---|---|---|
| | N/A | Ramp Length (in) | 42.0 | No | Ramp Slope (%) | 9.2 |

Remove & Replace Curb Ramp With Two New Directional Ramps or Equivalent.
