Access Compliance Report

Public Rights-of-Way

(Curb Ramps)

Intersection ID: 18436	Main Street: E_INDEPENDENCE_BV	Cross Street: SHARON_FOREST_DR	Location: SE
ADA ID: 64E8CD1BE4ED	Ramp Type: PerpDiag	Initial Pass/Fail: Fail	Overall Compliance: No
Severity Score: 22.5			
Codes/Mitigation Info/Possible Solution		Field Measurements/Component Compliance

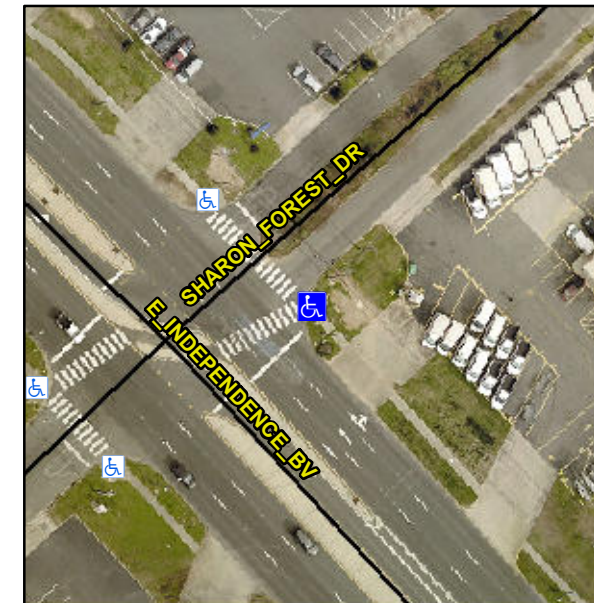
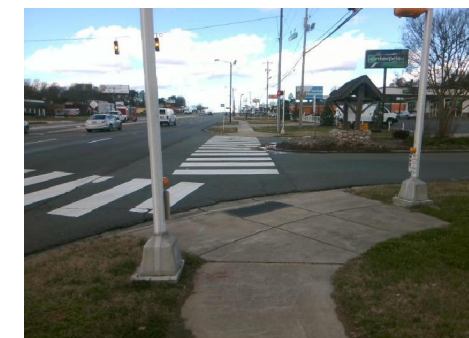
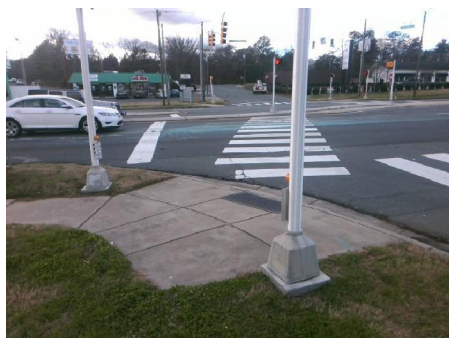
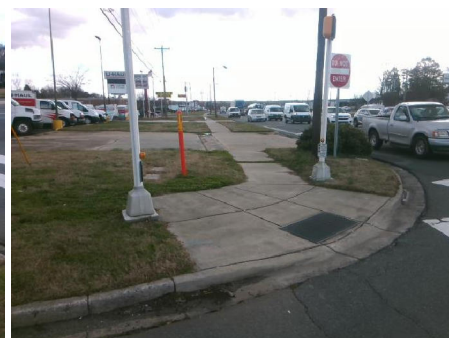
Not Found, R304.5.1, R304.2.2, R304.5.3

Compliance	Description	Data	Compliance	Description	Data
N/A	Ramp Length (in)	60.0	No	Ramp Slope (%)	9.3
No	Ramp Width (in)	41.0	No	Ramp XSlope (%)	3.8
N/A	Flare Type LT	N/A	N/A	Flare Type RT	N/A
N/A	Flare Slope LT (%)	N/A	N/A	Flare Slope RT (%)	N/A
N/A	Flare Traversable LT?	N/A	N/A	Flare Traversable RT?	N/A
N/A	Landing Length (in)	N/A	N/A	DWS Provided?	N/A
N/A	Landing Width (in)	N/A	N/A	DWS Contrast?	N/A
N/A	Landing Slope (%)	N/A	N/A	DWS Length (in)	N/A
N/A	Landing X Slope (%)	N/A	N/A	DWS Full Width?	N/A
N/A	Landing Curb? (Y/N)	N/A	N/A	DWS Offset (in)	N/A
N/A	Shared Landing?	N/A			
N/A	Gutter Ponding?	N/A	N/A	Gutter Slope (%)	N/A
N/A	Gutter Lip Ht (in)	N/A	N/A	Gutter X Slope (%)	N/A
N/A	Painted X Walk1?	Yes	N/A	Painted X Walk2?	Yes
	X Walk 1 Direction	To NW		X Walk 2 Direction	To SW
N/A	X Walk 1 Width (in)	117.0	N/A	X Walk 2 Width (in)	120.0
	X Walk 1 Slope (%)	6.2		X Walk 2 Slope (%)	4.5
	X Walk 1 X Slope (%)	0.0		X Walk 2 X Slope (%)	6.1

N/A	Ramp inside XWalk1?	Yes	N/A	Ramp inside XWalk2?	Yes
	Road Slope (%)	0.1	N/A	Clear Space?	N/A
	Road X Slope (%)	5.5	N/A	Clear Space to XWalk (in)	N/A
N/A	Any Obstructions?	N/A	N/A	Storm Grate/Utility Hazard?	N/A
	Obstruction Type			Storm Grate/Utility Type	
		N/A			N/A
		Yes		Surface Condition? (G/P)	Good

Remove & Replace Curb Ramp With Two New Directional Ramps or Equivalent.
