# Access Compliance Report

## Public Rights-of-Way

### (Curb Ramps)

Intersection ID: 18995	Main Street: SEACROFT_RD	Cross Street: TYVOLA_RD	Location: NE
ADA ID: 64ED0AECA931	Ramp Type: Perp	Initial Pass/Fail: Fail	Overall Compliance: No
Severity Score: 13.75			
Codes/Mitigation Info/Possible Solution		Field Measurements/Component Compliance

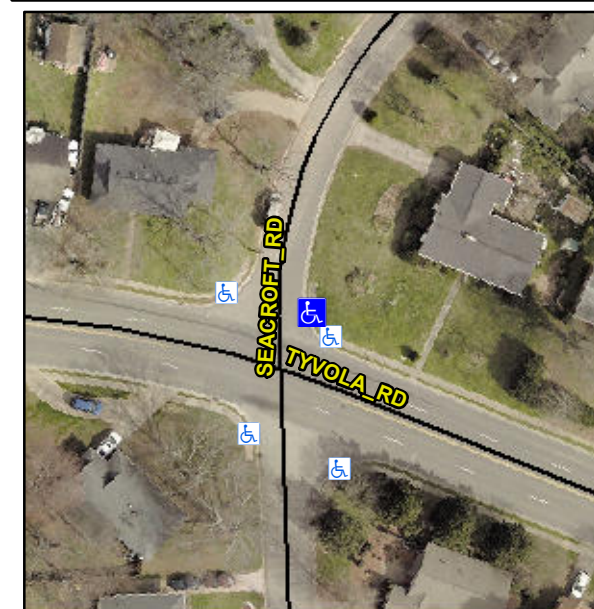
**Not Found, R304.2.2, R304.5.3**

Compliance	Description	Data	Compliance	Description	Data
N/A	Ramp Length (in)	26.5	No	Ramp Slope (%)	9.2
Yes	Ramp Width (in)	59.0	No	Ramp XSlope (%)	2.8
N/A	Flare Type LT	N/A	N/A	Flare Type RT	N/A
N/A	Flare Slope LT (%)	N/A	N/A	Flare Slope RT (%)	N/A
N/A	Flare Traversable LT?	N/A	N/A	Flare Traversable RT?	N/A
N/A	Landing Length (in)	N/A	N/A	DWS Provided?	N/A
N/A	Landing Width (in)	N/A	N/A	DWS Contrast?	N/A
N/A	Landing Slope (%)	N/A	N/A	DWS Length (in)	N/A
N/A	Landing X Slope (%)	N/A	N/A	DWS Full Width?	N/A
N/A	Landing Curb? (Y/N)	N/A	N/A	DWS Offset (in)	N/A
N/A	Shared Landing?	N/A			
N/A	Gutter Ponding?	N/A	N/A	Gutter Slope (%)	N/A
N/A	Gutter Lip Ht (in)	N/A	N/A	Gutter X Slope (%)	N/A
N/A	Painted X Walk1?	No	N/A	Painted X Walk2?	N/A
	X Walk 1 Direction	To NW		X Walk 2 Direction	N/A
N/A	X Walk 1 Width (in)	N/A	N/A	X Walk 2 Width (in)	N/A
	X Walk 1 Slope (%)	6.8		X Walk 2 Slope (%)	N/A
	X Walk 1 X Slope (%)	1.7		X Walk 2 X Slope (%)	N/A

N/A	Ramp inside XWalk1?	N/A	N/A	Ramp inside XWalk2?	N/A
	Road Slope (%)	N/A	N/A	Clear Space?	N/A
	Road X Slope (%)	N/A	N/A	Clear Space to XWalk (in)	N/A
N/A	Any Obstructions?	N/A	N/A	Storm Grate/Utility Hazard?	N/A
	Obstruction Type			Storm Grate/Utility Type	
		N/A			N/A
			Yes	Surface Condition? (G/P)	Good

**Remove & Replace Entire Ramp.**

Total Cost: \$ 1850.00
