Access Compliance Report

Public Rights-of-Way

(Curb Ramps)

Intersection ID: 4935	Main Street: OLD_STATESVILLE_RD	Cross Street: HENDERSON_CR	Location: W
ADA ID: 6502D56B14A9	Ramp Type: Perpendicular	Initial Pass/Fail: Fail	Overall Compliance: No
Codes/Mitigation Info/Possible Solution		Field Measurements/Component Compliance	
Severity Score: 42.5

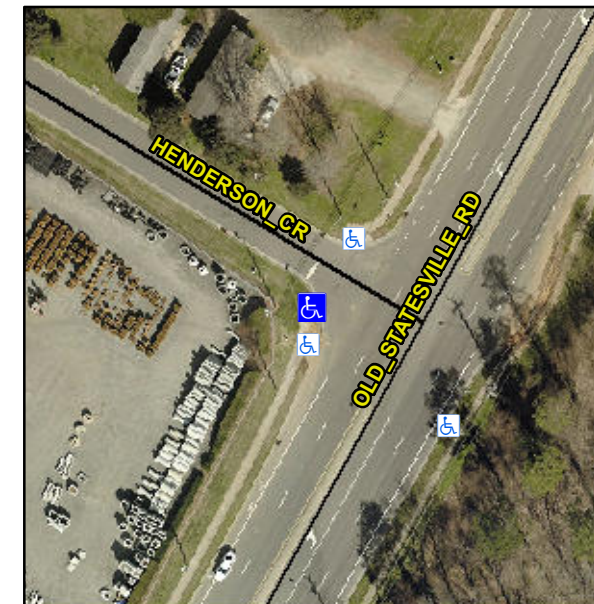
Not Found, R304.5.1, R304.2.2

Compliance	Description	Data	Compliance	Description	Data
N/A	Ramp Length (in)	61.0	No	Ramp Slope (%)	12.9
No	Ramp Width (in)	33.0	Yes	Ramp XSlope (%)	1.2
N/A	Flare Type LT	N/A	N/A	Flare Type RT	N/A
N/A	Flare Slope LT (%)	N/A	N/A	Flare Slope RT (%)	N/A
N/A	Flare Traversable LT?	N/A	N/A	Flare Traversable RT?	N/A
N/A	Landing Length (in)	N/A	N/A	DWS Provided?	N/A
N/A	Landing Width (in)	N/A	N/A	DWS Contrast?	N/A
N/A	Landing Slope (%)	N/A	N/A	DWS Length (in)	N/A
N/A	Landing X Slope (%)	N/A	N/A	DWS Full Width?	N/A
N/A	Landing Curb? (Y/N)	N/A	N/A	DWS Offset (in)	N/A
N/A	Shared Landing?	N/A			
N/A	Gutter Ponding?	N/A	N/A	Gutter Slope (%)	N/A
N/A	Gutter Lip Ht (in)	N/A	N/A	Gutter X Slope (%)	N/A
N/A	Painted X Walk1?	No	N/A	Painted X Walk2?	N/A
	X Walk 1 Direction	To NE		X Walk 2 Direction	N/A
N/A	X Walk 1 Width (in)	N/A	N/A	X Walk 2 Width (in)	N/A
	X Walk 1 Slope (%)	1.2		X Walk 2 Slope (%)	N/A
	X Walk 1 X Slope (%)	2.5		X Walk 2 X Slope (%)	N/A

N/A	Ramp inside XWalk1?	N/A	N/A	Ramp inside XWalk2?	N/A
	Road Slope (%)	N/A	N/A	Clear Space?	N/A
	Road X Slope (%)	N/A	N/A	Clear Space to XWalk (in)	N/A
N/A	Any Obstructions?	N/A	N/A	Storm Grate/Utility Hazard?	N/A
	Obstruction Type			Storm Grate/Utility Type	
		N/A			N/A
			Yes	Surface Condition? (G/P)	Good

Possible Solutions:

Remove & Replace Entire Ramp.
