Access Compliance Report

Public Rights-of-Way

(Curb Ramps)

Intersection ID: 14334	Main Street: BASCOM_ST	Cross Street: KINGSBURY_DR	Location:	N
ADA ID: 6511800E81D5	Ramp Type: Perpendicular Diagonal	Initial Pass/Fail: Pass	Overall Compliance: No	Severity Score: 12.5

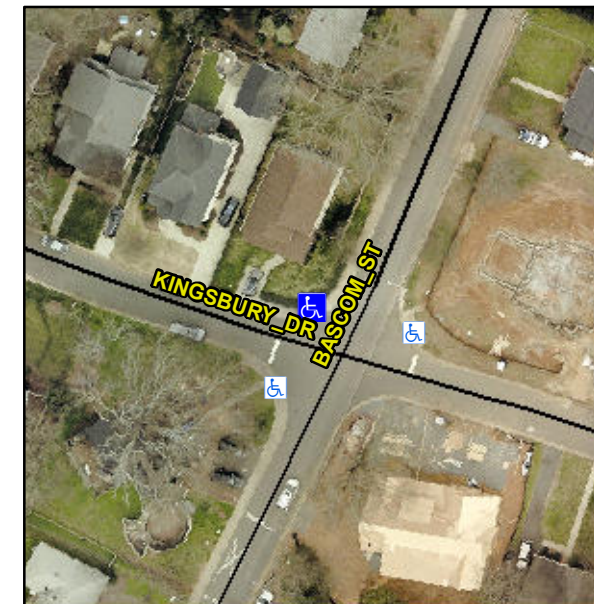
Remove & Replace Curb Ramp With Two New Directional Ramps or Equivalent. Gutter Ponding Observed.

Compliance	Description	Data	Compliance	Description	Data
N/A	Ramp Length (in)	60.0	Yes	Ramp Slope (%)	6.6
Yes	Ramp Width (in)	55.5	Yes	Ramp XSlope (%)	1.9
N/A	Flare Type LT	Sloped	N/A	Flare Type RT	N/A
N/A	Flare Slope LT (%)	2.6	Yes	Flare Slope RT (%)	3.0
N/A	Flare Traversable LT?	Yes	N/A	Flare Traversable RT?	Yes
No	Landing Length (in)	N/A	Yes	DWS Provided?	Yes
No	Landing Width (in)	N/A	Yes	DWS Contrast?	Yes
No	Landing Slope (%)	N/A	Yes	DWS Length (in)	25.0
No	Landing X Slope (%)	N/A	No	DWS Full Width?	No
N/A	Landing Curb? (Y/N)	No	No	DWS Offset (in)	3.0
N/A	Shared Landing?	N/A			
No	Gutter Ponding?	Yes	Yes	Gutter Slope (%)	0.9
Yes	Gutter Lip Ht (in)	0.0	Yes	Gutter X Slope (%)	1.1
N/A	Painted X Walk1?	No	N/A	Painted X Walk2?	No
	X Walk 1 Direction	To SW		X Walk 2 Direction	To SE
N/A	X Walk 1 Width (in)	N/A	N/A	X Walk 2 Width (in)	N/A
	X Walk 1 Slope (%)	1.7		X Walk 2 Slope (%)	0.4
	X Walk 1 X Slope (%)	0.3		X Walk 2 X Slope (%)	0.6

N/A	Ramp inside XWalk1?	N/A	N/A	Ramp inside XWalk2?	N/A
	Road Slope (%)	1.3	N/A	Clear Space?	Yes
	Road X Slope (%)	0.1	N/A	Clear Space to XWalk (in)	N/A
Yes	Any Obstructions?	No	Yes	Storm Grate/Utility Hazard?	No
	Obstruction Type			Storm Grate/Utility Type	
		N/A			N/A
			Yes	Surface Condition? (G/P)	Good

Possible Solutions:
