# Access Compliance Report

## Public Rights-of-Way

### (Curb Ramps)

Intersection ID: 10940	Main Street: COLBY_PL	Cross Street: MILTON_RD	Location:	N
ADA ID: 65171C462828	Ramp Type: Perpendicular Diagonal	Initial Pass/Fail: Fail	Overall Compliance: No	Severity Score: 21.25
Codes/Mitigation Info/Possible Solution		Field Measurements/Component Compliance

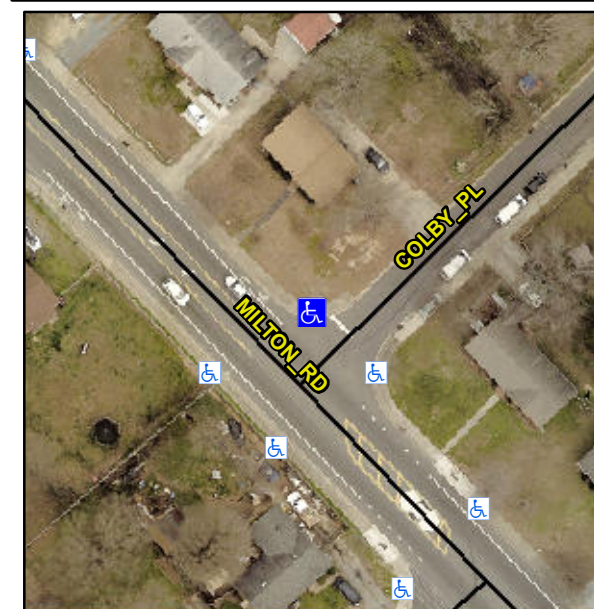
**Not Found, R304.5.1, R304.2.2**

Compliance	Description	Data	Compliance	Description	Data
N/A	Ramp Length (in)	59.5	No	Ramp Slope (%)	10.9
No	Ramp Width (in)	37.5	Yes	Ramp XSlope (%)	1.8
N/A	Flare Type LT	N/A	N/A	Flare Type RT	N/A
N/A	Flare Slope LT (%)	N/A	N/A	Flare Slope RT (%)	N/A
N/A	Flare Traversable LT?	N/A	N/A	Flare Traversable RT?	N/A
N/A	Landing Length (in)	N/A	N/A	DWS Provided?	N/A
N/A	Landing Width (in)	N/A	N/A	DWS Contrast?	N/A
N/A	Landing Slope (%)	N/A	N/A	DWS Length (in)	N/A
N/A	Landing X Slope (%)	N/A	N/A	DWS Full Width?	N/A
N/A	Landing Curb? (Y/N)	N/A	N/A	DWS Offset (in)	N/A
N/A	Shared Landing?	N/A			
N/A	Gutter Ponding?	N/A	N/A	Gutter Slope (%)	N/A
N/A	Gutter Lip Ht (in)	N/A	N/A	Gutter X Slope (%)	N/A
N/A	Painted X Walk1?	No	N/A	Painted X Walk2?	No
	X Walk 1 Direction	To SW		X Walk 2 Direction	To SE
N/A	X Walk 1 Width (in)	N/A	N/A	X Walk 2 Width (in)	N/A
	X Walk 1 Slope (%)	3.4		X Walk 2 Slope (%)	4.0
	X Walk 1 X Slope (%)	2.1		X Walk 2 X Slope (%)	2.1

N/A	Ramp inside XWalk1?	N/A	N/A	Ramp inside XWalk2?	N/A
	Road Slope (%)	1.2	N/A	Clear Space?	N/A
	Road X Slope (%)	1.2	N/A	Clear Space to XWalk (in)	N/A
N/A	Any Obstructions?	N/A	N/A	Storm Grate/Utility Hazard?	N/A
	Obstruction Type			Storm Grate/Utility Type	
		N/A			N/A
			Yes	Surface Condition? (G/P)	Good

**Remove & Replace Curb Ramp With Two New Directional Ramps or Equivalent.**
