Access Compliance Report Public Rights-of-Way (Curb Ramps)

Intersection ID: 10328 Main Street: N_BREVARD_ST Cross Street: N_DAVIDSON_ST Location: W ADA ID: 651EF7D15788 Ramp Type: BlendTrans2 Initial Pass/Fail: Fail **Overall Compliance: No Severity Score:** 8.75

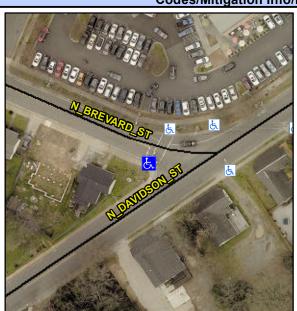
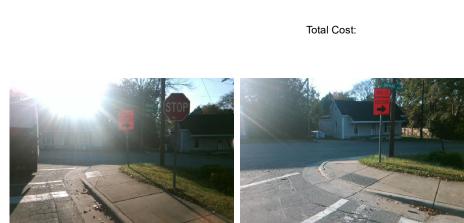
Not Found, R304.5.1

| Field Measurements/Component Compliance | | | | | |
|---|---|---|---|---|---|
| No | Ramp Width (in) | 46.5 | Yes | BlendTrans XSlope (%) | 0.2 |
| | and the second second | | No | Curb Slope (%) | 13.8 |

N BREVARD ST Street 1 Name Stop Condition-Street 1 StopSign Street 2 Name N/A Stop Condition-Street 2 N/A Remove & Replace Curb Ramp With Two New Directional Ramps or Equivalent.
