# Access Compliance Report

## Public Rights-of-Way

| Intersection ID: 18863 | Main Street: DAMERON_ST | Cross Street: SELWYN_AV | Location: | E |
| ADA ID: 6520985C1C4A | Ramp Type: Perpendicular Diagonal | Initial Pass/Fail: Fail | Overall Compliance: No | Severity Score: 10 |

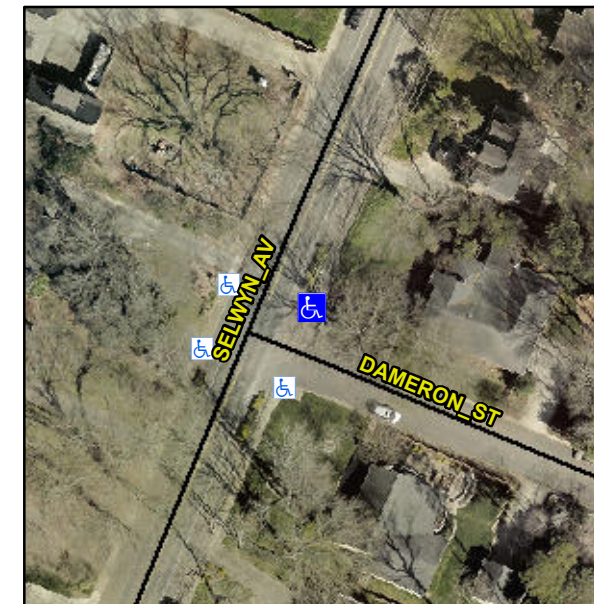
**R304.5.1, R304.5.3**

| Compliance | Description | Data | Compliance | Description | Data |
|---|---|---|---|---|---|
| N/A | Ramp Length (in) | 72.0 | Yes | Ramp Slope (%) | 7.6 |
| No | Ramp Width (in) | 41.0 | No | Ramp XSlope (%) | 3.5 |

**Remove & Replace Curb Ramp With Two New Directional Ramps or Equivalent.**

Total Cost: \$ 3200.00
