Access Compliance Report

Public Rights-of-Way

(Curb Ramps)

Intersection ID: 13641	Main Street: BAY_ST	Cross Street: CLEMENT_AV	Location:	N
ADA ID: 652558A2C323	Ramp Type: Perpendicular Diagonal	Initial Pass/Fail: Fail	Overall Compliance: No	Severity Score: 12.5

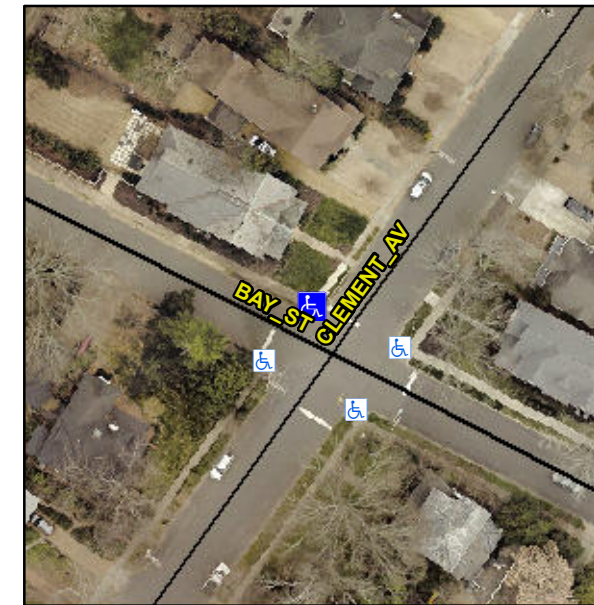
Not Found, R304.2.2

Compliance	Description	Data	Compliance	Description	Data
N/A	Ramp Length (in)	54.5	No	Ramp Slope (%)	11.6
Yes	Ramp Width (in)	122.0	Yes	Ramp XSlope (%)	0.4
N/A	Flare Type LT	N/A	N/A	Flare Type RT	N/A
N/A	Flare Slope LT (%)	N/A	N/A	Flare Slope RT (%)	N/A
N/A	Flare Traversable LT?	N/A	N/A	Flare Traversable RT?	N/A
N/A	Landing Length (in)	N/A	N/A	DWS Provided?	N/A
N/A	Landing Width (in)	N/A	N/A	DWS Contrast?	N/A
N/A	Landing Slope (%)	N/A	N/A	DWS Length (in)	N/A
N/A	Landing X Slope (%)	N/A	N/A	DWS Full Width?	N/A
N/A	Landing Curb? (Y/N)	N/A	N/A	DWS Offset (in)	N/A
N/A	Shared Landing?	N/A			
N/A	Gutter Ponding?	N/A	N/A	Gutter Slope (%)	N/A
N/A	Gutter Lip Ht (in)	N/A	N/A	Gutter X Slope (%)	N/A
N/A	Painted X Walk1?	No	N/A	Painted X Walk2?	No
	X Walk 1 Direction	To SW		X Walk 2 Direction	To SE
N/A	X Walk 1 Width (in)	N/A	N/A	X Walk 2 Width (in)	N/A
	X Walk 1 Slope (%)	1.2		X Walk 2 Slope (%)	3.0
	X Walk 1 X Slope (%)	1.8		X Walk 2 X Slope (%)	0.3

Remove & Replace Curb Ramp With Two New Directional Ramps or Equivalent.
