# Access Compliance Report

## Public Rights-of-Way

### (Curb Ramps)

Intersection ID: 11842	Main Street: CAGLE_AV	Cross Street: N_SHARON_AMITY_RD	Location: NE
ADA ID: 6525DFE6F626	Ramp Type: Perpendicular	Initial Pass/Fail: Fail	Overall Compliance: No
Severity Score: 12.5			
Codes/Mitigation Info/Possible Solution		Field Measurements/Component Compliance

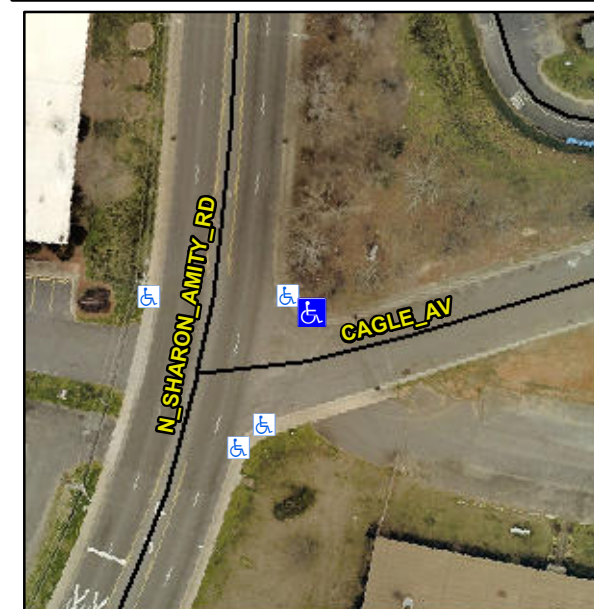
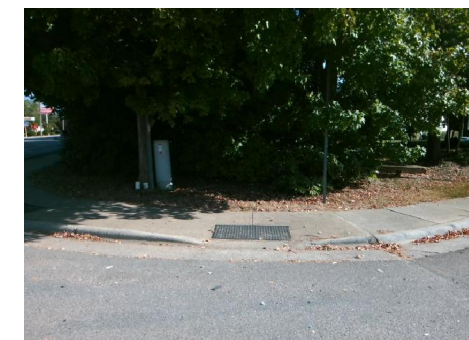
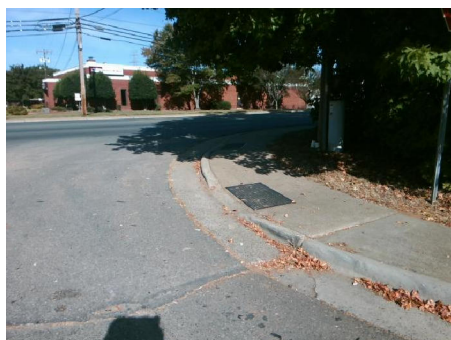
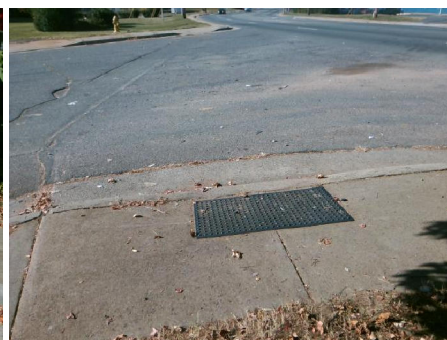
**Not Found, R304.2.2**

Compliance	Description	Data	Compliance	Description	Data
N/A	Ramp Length (in)	59.5	No	Ramp Slope (%)	8.4
Yes	Ramp Width (in)	48.0	Yes	Ramp XSlope (%)	1.7
N/A	Flare Type LT	N/A	N/A	Flare Type RT	N/A
N/A	Flare Slope LT (%)	N/A	N/A	Flare Slope RT (%)	N/A
N/A	Flare Traversable LT?	N/A	N/A	Flare Traversable RT?	N/A
N/A	Landing Length (in)	N/A	N/A	DWS Provided?	N/A
N/A	Landing Width (in)	N/A	N/A	DWS Contrast?	N/A
N/A	Landing Slope (%)	N/A	N/A	DWS Length (in)	N/A
N/A	Landing X Slope (%)	N/A	N/A	DWS Full Width?	N/A
N/A	Landing Curb? (Y/N)	N/A	N/A	DWS Offset (in)	N/A
N/A	Shared Landing?	N/A			
N/A	Gutter Ponding?	N/A	N/A	Gutter Slope (%)	N/A
N/A	Gutter Lip Ht (in)	N/A	N/A	Gutter X Slope (%)	N/A
N/A	Painted X Walk1?	No	N/A	Painted X Walk2?	N/A
	X Walk 1 Direction	To SW		X Walk 2 Direction	N/A
N/A	X Walk 1 Width (in)	N/A	N/A	X Walk 2 Width (in)	N/A
	X Walk 1 Slope (%)	0.2		X Walk 2 Slope (%)	N/A
	X Walk 1 X Slope (%)	2.2		X Walk 2 X Slope (%)	N/A

**Remove & Replace Entire Ramp.**
