Access Compliance Report

Public Rights-of-Way

(Curb Ramps)

Intersection ID: 17680	Main Street: GREENWICH_RD	Cross Street: RANDOLPH_RD	Location: NE
ADA ID: 6526DBC41B83	Ramp Type: Perpendicular Diagonal	Initial Pass/Fail: Fail	Overall Compliance: No
		Severity Score: 12.5

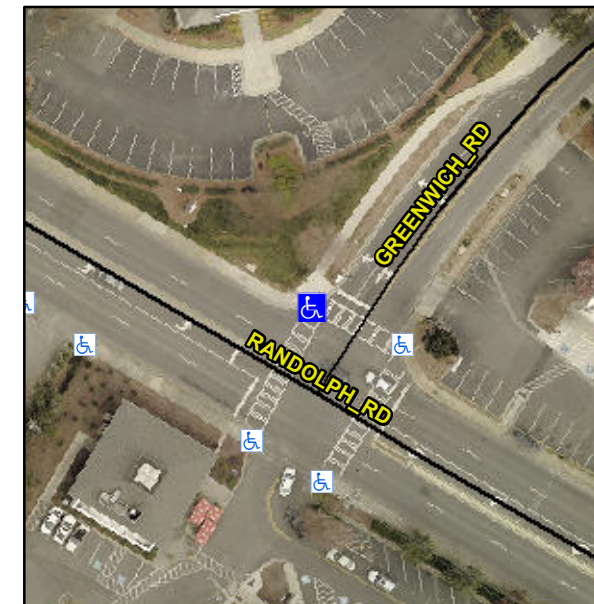
Compliance	Description	Data	Compliance	Description	Data
N/A	Ramp Length (in)	51.0	No	Ramp Slope (%)	10.7
Yes	Ramp Width (in)	72.0	Yes	Ramp XSlope (%)	0.4
N/A	Flare Type LT	N/A	N/A	Flare Type RT	N/A
N/A	Flare Slope LT (%)	N/A	N/A	Flare Slope RT (%)	N/A
N/A	Flare Traversable LT?	N/A	N/A	Flare Traversable RT?	N/A
N/A	Landing Length (in)	N/A	N/A	DWS Provided?	N/A
N/A	Landing Width (in)	N/A	N/A	DWS Contrast?	N/A
N/A	Landing Slope (%)	N/A	N/A	DWS Length (in)	N/A
N/A	Landing X Slope (%)	N/A	N/A	DWS Full Width?	N/A
N/A	Landing Curb? (Y/N)	N/A	N/A	DWS Offset (in)	N/A
N/A	Shared Landing?	N/A			
N/A	Gutter Ponding?	N/A	N/A	Gutter Slope (%)	N/A
N/A	Gutter Lip Ht (in)	N/A	N/A	Gutter X Slope (%)	N/A
N/A	Painted X Walk1?	Yes	N/A	Painted X Walk2?	Yes
	X Walk 1 Direction	To SW		X Walk 2 Direction	To SE
N/A	X Walk 1 Width (in)	106.0	N/A	X Walk 2 Width (in)	112.0
	X Walk 1 Slope (%)	4.5		X Walk 2 Slope (%)	3.3
	X Walk 1 X Slope (%)	3.2		X Walk 2 X Slope (%)	2.8

N/A	Ramp inside XWalk1?	Yes	N/A	Ramp inside XWalk2?	Yes
	Road Slope (%)	0.7	N/A	Clear Space?	N/A
	Road X Slope (%)	4.3	N/A	Clear Space to XWalk (in)	N/A
N/A	Any Obstructions?	N/A	N/A	Storm Grate/Utility Hazard?	N/A
	Obstruction Type			Storm Grate/Utility Type	
		N/A			N/A
		Yes		Surface Condition? (G/P)	Good

Possible Solutions:

Remove & Replace Curb Ramp With Two New Directional Ramps or Equivalent.

R304.2.2
