# Access Compliance Report

## Public Rights-of-Way

### (Curb Ramps)

| Intersection ID: 8193 | Main Street: E_W_T_HARRIS_BV | Cross Street: GRIER_RD | Location: SE |

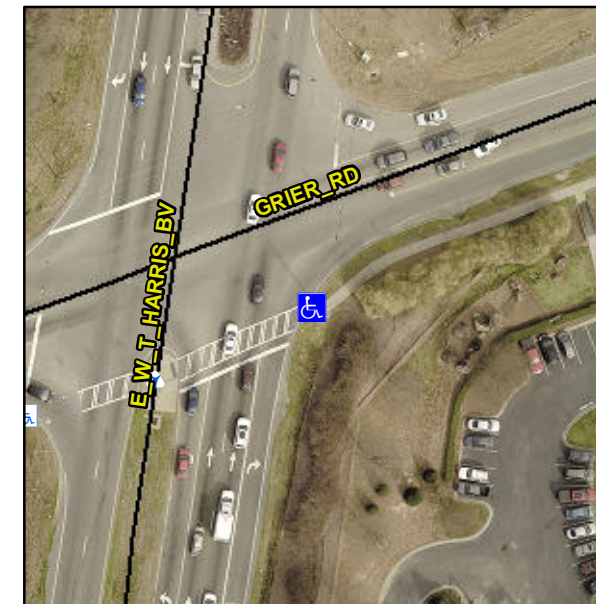
| Severity Score: 7.5 | | | |

**Not Found, R304.2.2-Perp, R304.3.2-  
Para, R304.5.3, R305.2, R302.7,  
R302.7.2**

| Compliance | Description | Data | Compliance | Description | Data |
|---|---|---|---|---|---|
| Yes | Ramp Width (in) | 67.0 | No | Grade Break Slope (%) | 5.8 |
| No | Landing Slope (%) | 6.0 | Yes | DWS Length (in) | 25.0 |
| No | Gutter Ponding? | Yes | Yes | Gutter Slope (%) | 0.3 |
| No | Gutter Lip Ht (in) | 0.5 | No | Gutter X Slope (%) | 5.1 |

**Remove & Replace Entire Ramp.  
Remove & Replace Gutter.**

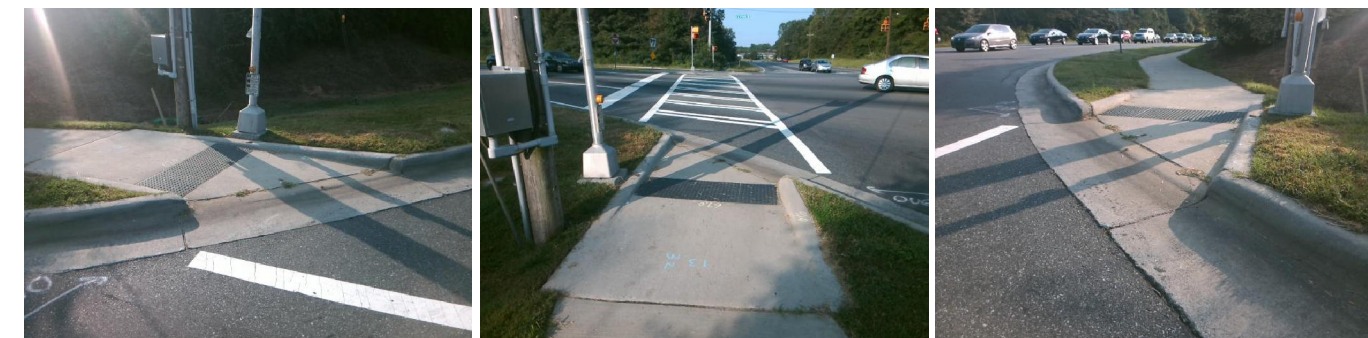
| Codes/Mitigation Info/Possible Solution | | Field Measurements/Component Compliance | |

PROW/ADA:

Possible Solutions:
