# Access Compliance Report

## Public Rights-of-Way

Intersection ID: 30018	Main Street: W MALLARD CREEK CHURCH RD	Cross Street: BERKELEY PLACE DR	Location: SE
ADA ID: 653CCD8390C7	Ramp Type: Perpendicular	Initial Pass/Fail: Fail	Overall Compliance: No
Severity Score: 12.5			
Codes/Mitigation Info/Possible Solution		Field Measurements/Component Compliance

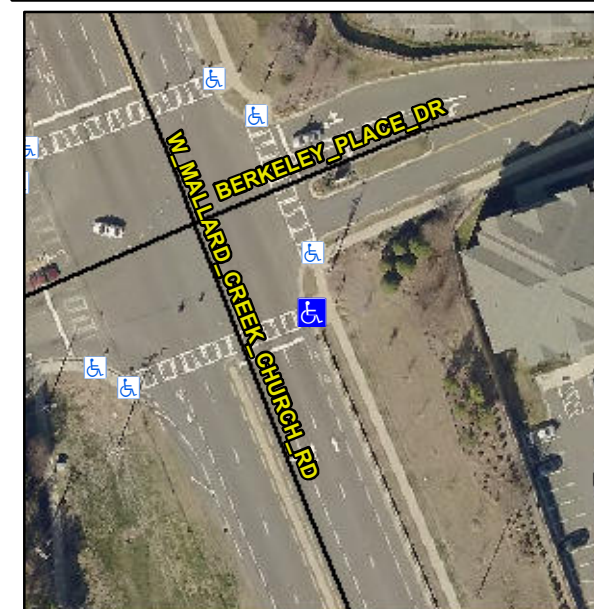
Compliance	Description	Data	Compliance	Description	Data
N/A	Ramp Length (in)	86.0	No	Ramp Slope (%)	9.9
Yes	Ramp Width (in)	48.0	Yes	Ramp XSlope (%)	0.1
N/A	Flare Type LT	N/A	N/A	Flare Type RT	N/A
N/A	Flare Slope LT (%)	N/A	N/A	Flare Slope RT (%)	N/A
N/A	Flare Traversable LT?	N/A	N/A	Flare Traversable RT?	N/A
N/A	Landing Length (in)	N/A	N/A	DWS Provided?	N/A
N/A	Landing Width (in)	N/A	N/A	DWS Contrast?	N/A
N/A	Landing Slope (%)	N/A	N/A	DWS Length (in)	N/A
N/A	Landing X Slope (%)	N/A	N/A	DWS Full Width?	N/A
N/A	Landing Curb? (Y/N)	N/A	N/A	DWS Offset (in)	N/A
N/A	Shared Landing?	N/A			
N/A	Gutter Ponding?	N/A	N/A	Gutter Slope (%)	N/A
N/A	Gutter Lip Ht (in)	N/A	N/A	Gutter X Slope (%)	N/A
N/A	Painted X Walk1?	Yes	N/A	Painted X Walk2?	N/A
	X Walk 1 Direction	To W		X Walk 2 Direction	N/A
N/A	X Walk 1 Width (in)	102.5	N/A	X Walk 2 Width (in)	N/A
	X Walk 1 Slope (%)	2.9		X Walk 2 Slope (%)	N/A
	X Walk 1 X Slope (%)	1.3		X Walk 2 X Slope (%)	N/A

N/A	Ramp inside XWalk1?	Yes	N/A	Ramp inside XWalk2?	N/A
	Road Slope (%)	N/A	N/A	Clear Space?	N/A
	Road X Slope (%)	N/A	N/A	Clear Space to XWalk (in)	N/A
N/A	Any Obstructions?	N/A	N/A	Storm Grate/Utility Hazard?	N/A
	Obstruction Type			Storm Grate/Utility Type	
		N/A			N/A
			Yes	Surface Condition? (G/P)	Good

Possible Solutions:

**Remove & Replace Entire Ramp.**

**R304.2.2**
