Access Compliance Report

Public Rights-of-Way

(Curb Ramps)

Intersection ID: 10254	Main Street: CALLAHAN_ST	Cross Street: SPRING_ST	Location: SW
ADA ID: 655262519E2F	Ramp Type: Perpendicular Diagonal	Initial Pass/Fail: Fail	Overall Compliance: No
		Severity Score: 12.5

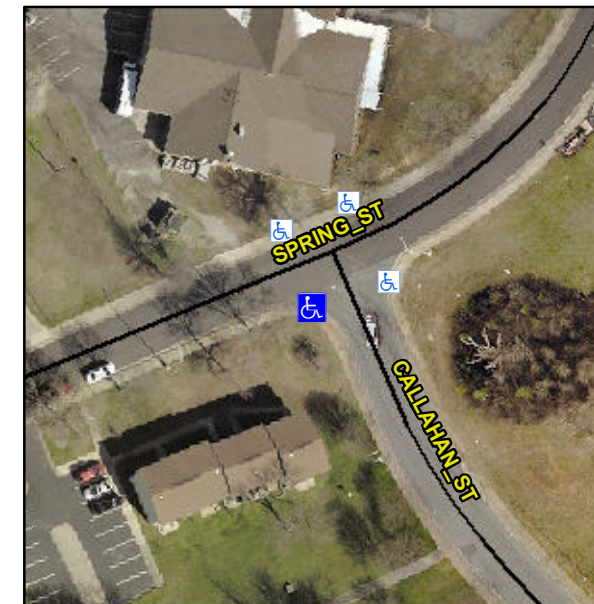
Compliance	Description	Data	Compliance	Description	Data
N/A	Ramp Length (in)	67.0	No	Ramp Slope (%)	8.7
Yes	Ramp Width (in)	58.5	Yes	Ramp XSlope (%)	1.6
N/A	Flare Type LT	N/A	N/A	Flare Type RT	N/A
N/A	Flare Slope LT (%)	N/A	N/A	Flare Slope RT (%)	N/A
N/A	Flare Traversable LT?	N/A	N/A	Flare Traversable RT?	N/A
N/A	Landing Length (in)	N/A	N/A	DWS Provided?	N/A
N/A	Landing Width (in)	N/A	N/A	DWS Contrast?	N/A
N/A	Landing Slope (%)	N/A	N/A	DWS Length (in)	N/A
N/A	Landing X Slope (%)	N/A	N/A	DWS Full Width?	N/A
N/A	Landing Curb? (Y/N)	N/A	N/A	DWS Offset (in)	N/A
N/A	Shared Landing?	N/A			
N/A	Gutter Ponding?	N/A	N/A	Gutter Slope (%)	N/A
N/A	Gutter Lip Ht (in)	N/A	N/A	Gutter X Slope (%)	N/A
N/A	Painted X Walk1?	No	N/A	Painted X Walk2?	No
	X Walk 1 Direction	To E		X Walk 2 Direction	To N
N/A	X Walk 1 Width (in)	N/A	N/A	X Walk 2 Width (in)	N/A
	X Walk 1 Slope (%)	6.5		X Walk 2 Slope (%)	1.9
	X Walk 1 X Slope (%)	0.6		X Walk 2 X Slope (%)	3.2

N/A	Ramp inside XWalk1?	N/A	N/A	Ramp inside XWalk2?	N/A
	Road Slope (%)	1.9	N/A	Clear Space?	N/A
	Road X Slope (%)	4.5	N/A	Clear Space to XWalk (in)	N/A
N/A	Any Obstructions?	N/A	N/A	Storm Grate/Utility Hazard?	N/A
	Obstruction Type			Storm Grate/Utility Type	
		N/A			N/A
			Yes	Surface Condition? (G/P)	Good

Remove & Replace Curb Ramp With Two New Directional Ramps or Equivalent.

R304.2.2
