Access Compliance Report

Public Rights-of-Way

(Curb Ramps)

Intersection ID: 5967	Main Street: N_TRYON_ST	Cross Street: MCCULLOUGH_DR	Location: SW
ADA ID: 65533E585050	Ramp Type: Perpendicular	Initial Pass/Fail: Fail	Overall Compliance: No
Codes/Mitigation Info/Possible Solution		Field Measurements/Component Compliance	
Severity Score: 8.75

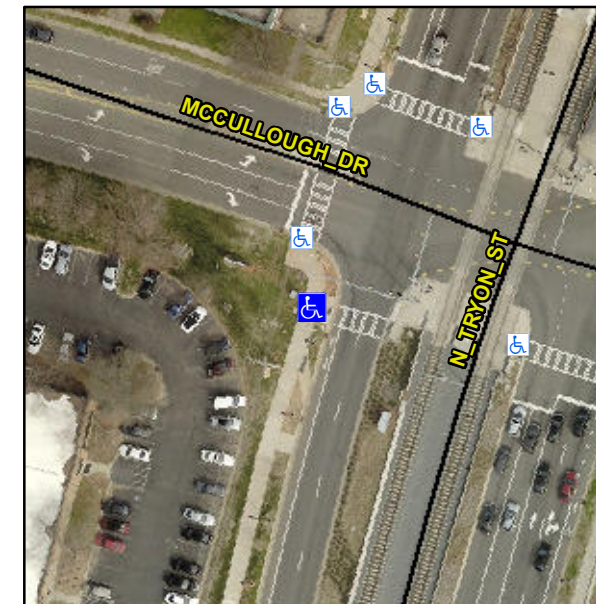
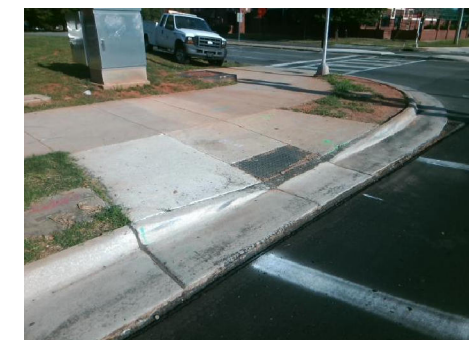
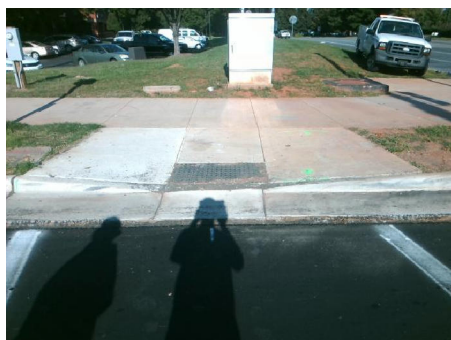
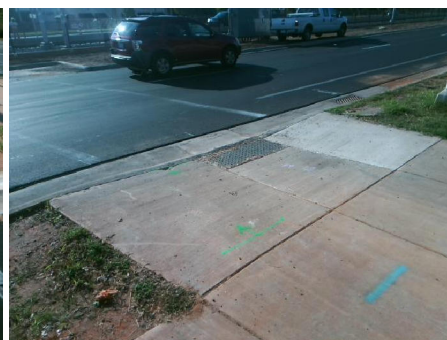
Not Found, R304.5.1

Compliance	Description	Data	Compliance	Description	Data
N/A	Ramp Length (in)	83.5	Yes	Ramp Slope (%)	6.9
No	Ramp Width (in)	47.0	Yes	Ramp XSlope (%)	0.2
N/A	Flare Type LT	N/A	N/A	Flare Type RT	N/A
N/A	Flare Slope LT (%)	N/A	N/A	Flare Slope RT (%)	N/A
N/A	Flare Traversable LT?	N/A	N/A	Flare Traversable RT?	N/A
N/A	Landing Length (in)	N/A	N/A	DWS Provided?	N/A
N/A	Landing Width (in)	N/A	N/A	DWS Contrast?	N/A
N/A	Landing Slope (%)	N/A	N/A	DWS Length (in)	N/A
N/A	Landing X Slope (%)	N/A	N/A	DWS Full Width?	N/A
N/A	Landing Curb? (Y/N)	N/A	N/A	DWS Offset (in)	N/A
N/A	Shared Landing?	N/A			
N/A	Gutter Ponding?	N/A	N/A	Gutter Slope (%)	N/A
N/A	Gutter Lip Ht (in)	2.0	N/A	Gutter X Slope (%)	N/A
N/A	Painted X Walk1?	No	N/A	Painted X Walk2?	N/A
	X Walk 1 Direction	To SE		X Walk 2 Direction	N/A
N/A	X Walk 1 Width (in)	N/A	N/A	X Walk 2 Width (in)	N/A
	X Walk 1 Slope (%)	1.9		X Walk 2 Slope (%)	N/A
	X Walk 1 X Slope (%)	0.7		X Walk 2 X Slope (%)	N/A

N/A	Ramp inside XWalk1?	N/A	N/A	Ramp inside XWalk2?	N/A
	Road Slope (%)	N/A	N/A	Clear Space?	N/A
	Road X Slope (%)	N/A	N/A	Clear Space to XWalk (in)	N/A
N/A	Any Obstructions?	N/A	N/A	Storm Grate/Utility Hazard?	N/A
	Obstruction Type			Storm Grate/Utility Type	
		N/A			N/A
			Yes	Surface Condition? (G/P)	Good

Remove & Replace Entire Ramp.

Total Cost: \$ 1850.00
