Access Compliance Report

Public Rights-of-Way

(Curb Ramps)

Intersection ID: 11838	Main Street: MECKLENBURG_AV	Cross Street: LYNHAVEN_ST	Location: NW
ADA ID: 6558FA15D69C	Ramp Type: Directional1	Initial Pass/Fail: Fail	Overall Compliance: No
		Severity Score: 13.75

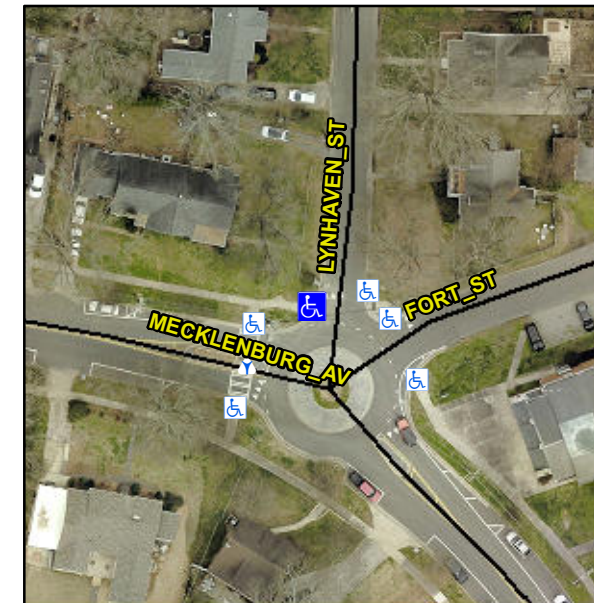
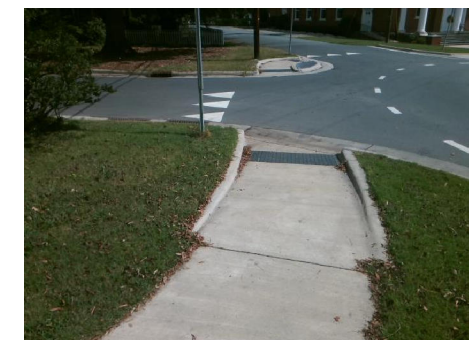
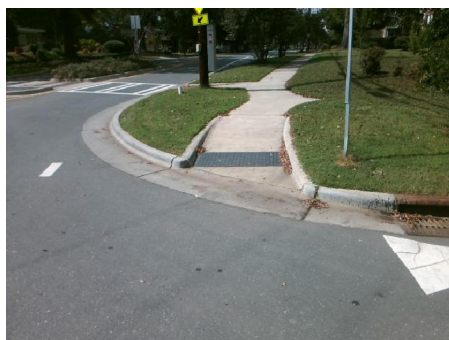
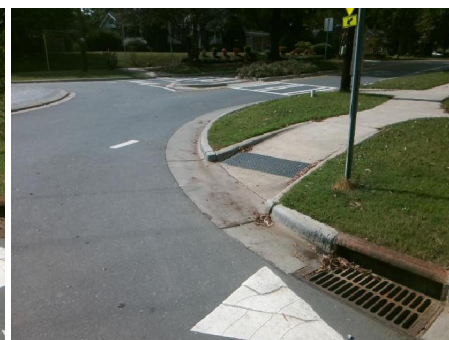
R304.2.2, R304.5.3

Compliance	Description	Data	Compliance	Description	Data
N/A	Ramp Length (in)	147.0	N/A	Grade Break?	N/A
Yes	Ramp Width (in)	57.0	N/A	Grade Break Slope (%)	0.0
No	Ramp Slope (%)	10.8	N/A	Grade Break XSlope (%)	0.0
No	Ramp XSlope (%)	3.2			
N/A	Flare Type LT	N/A	N/A	Flare Type RT	N/A
N/A	Flare Slope LT (%)	N/A	N/A	Flare Slope RT (%)	0.0
N/A	Flare Traversable LT?	N/A	N/A	Flare Traversable RT?	N/A
N/A	Landing Length (in)	0.0	N/A	DWS Provided?	N/A
N/A	Landing Width (in)	0.0	N/A	DWS Contrast?	N/A
N/A	Landing Slope (%)	0.0	N/A	DWS Length (in)	N/A
N/A	Landing X Slope (%)	0.0	N/A	DWS Full Width?	N/A
N/A	Landing Curb? (Y/N)	N/A	N/A	DWS Offset LT (in)	N/A
N/A	Shared Landing?	N/A	N/A	DWS Offset RT (in)	N/A
N/A	Gutter Ponding?	0.0	N/A	Gutter Slope (%)	N/A
N/A	Gutter Lip Ht (in)	0.0	N/A	Gutter X Slope (%)	N/A
N/A	Painted X Walk1?	No		Road Slope (%)	0.0
	X Walk 1 Direction	To E		Road X Slope (%)	0.1
	X Walk 1 Width (in)	N/A		Clear Space?	N/A

X Walk 1 Slope (%)	0.0	N/A	Clear Space to XWalk (in)	N/A
	X Walk 1 X Slope (%)	0.1	N/A	Storm Grate/Utility Hazard?	N/A
N/A	Ramp inside XWalk1?	N/A		Storm Grate/Utility Type	
N/A	Any Obstructions?	N/A			N/A
	Obstruction Type		Yes	Surface Condition? (G/P)	Good
			N/A	Curb Slope (%)	6.1

Remove & Replace Entire Ramp.
