Access Compliance Report

Public Rights-of-Way

(Curb Ramps)

Intersection ID: 7276	Main Street: HUNTER_OAKS_LN	Cross Street: TOM_HUNTER_RD	Location: NW
ADA ID: 655E076CCC6F	Ramp Type: Perpendicular	Initial Pass/Fail: Fail	Overall Compliance: No
Severity Score: 25			
Codes/Mitigation Info/Possible Solution		Field Measurements/Component Compliance

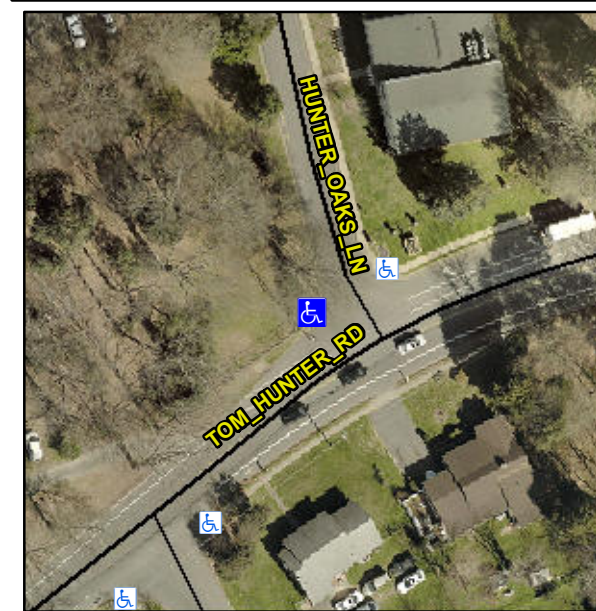
Not Found, R304.2.2

Compliance	Description	Data	Compliance	Description	Data
N/A	Ramp Length (in)	61.0	No	Ramp Slope (%)	13.8
Yes	Ramp Width (in)	48.0	Yes	Ramp XSlope (%)	1.4
N/A	Flare Type LT	N/A	N/A	Flare Type RT	N/A
N/A	Flare Slope LT (%)	N/A	N/A	Flare Slope RT (%)	N/A
N/A	Flare Traversable LT?	N/A	N/A	Flare Traversable RT?	N/A
N/A	Landing Length (in)	N/A	N/A	DWS Provided?	N/A
N/A	Landing Width (in)	N/A	N/A	DWS Contrast?	N/A
N/A	Landing Slope (%)	N/A	N/A	DWS Length (in)	N/A
N/A	Landing X Slope (%)	N/A	N/A	DWS Full Width?	N/A
N/A	Landing Curb? (Y/N)	N/A	N/A	DWS Offset (in)	N/A
N/A	Shared Landing?	N/A			
N/A	Gutter Ponding?	N/A	N/A	Gutter Slope (%)	N/A
N/A	Gutter Lip Ht (in)	N/A	N/A	Gutter X Slope (%)	N/A
N/A	Painted X Walk1?	No	N/A	Painted X Walk2?	N/A
	X Walk 1 Direction	To NE		X Walk 2 Direction	N/A
N/A	X Walk 1 Width (in)	N/A	N/A	X Walk 2 Width (in)	N/A
	X Walk 1 Slope (%)	0.8		X Walk 2 Slope (%)	N/A
	X Walk 1 X Slope (%)	3.2		X Walk 2 X Slope (%)	N/A

Possible Solutions:

Remove & Replace Entire Ramp.
