Access Compliance Report

Public Rights-of-Way

(Curb Ramps)

Intersection ID: 10040846	Main Street: WAKEFIELD_DR	Cross Street: N/A	Location: S
ADA ID: 656E892DF7C2	Ramp Type: Perpendicular	Initial Pass/Fail: Pass	Overall Compliance: No
		Severity Score: 0

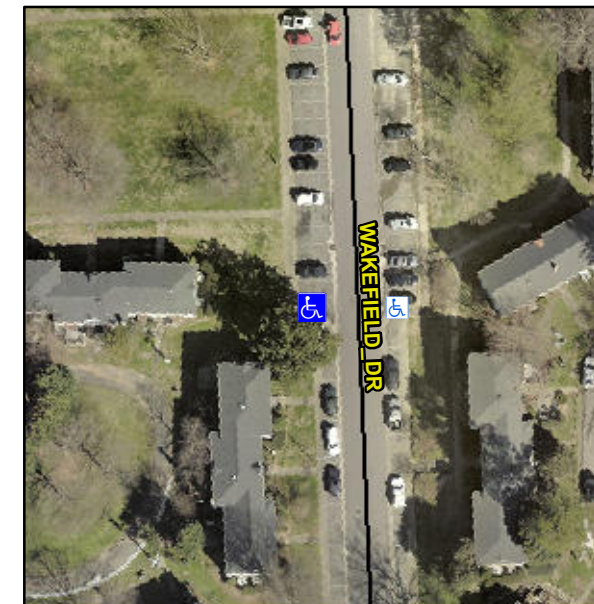
Not Found, R304.2.2-Perp, R304.3.2-Para, R305.2

Compliance	Description	Data	Compliance	Description	Data
N/A	Ramp Length (in)	88.0	Yes	Ramp Slope (%)	5.3
Yes	Ramp Width (in)	48.0	Yes	Ramp XSlope (%)	1.8
N/A	Flare Type LT	Sloped	N/A	Flare Type RT	N/A
N/A	Flare Slope LT (%)	0.4	Yes	Flare Slope RT (%)	0.2
N/A	Flare Traversable LT?	Yes	N/A	Flare Traversable RT?	Yes
Yes	Landing Length (in)	57.0	Yes	DWS Provided?	Yes
Yes	Landing Width (in)	53.0	Yes	DWS Contrast?	Yes
No	Landing Slope (%)	6.1	Yes	DWS Length (in)	24.0
Yes	Landing X Slope (%)	1.6	Yes	DWS Full Width?	Yes
N/A	Landing Curb? (Y/N)	No	No	DWS Offset (in)	6.0
N/A	Shared Landing?	No			
Yes	Gutter Ponding?	No	Yes	Gutter Slope (%)	2.3
Yes	Gutter Lip Ht (in)	0.0	Yes	Gutter X Slope (%)	0.0
N/A	Painted X Walk1?	No	N/A	Painted X Walk2?	N/A
	X Walk 1 Direction	To N		X Walk 2 Direction	N/A
N/A	X Walk 1 Width (in)	N/A	N/A	X Walk 2 Width (in)	N/A
	X Walk 1 Slope (%)	5.2		X Walk 2 Slope (%)	N/A
	X Walk 1 X Slope (%)	1.2		X Walk 2 X Slope (%)	N/A

N/A	Ramp inside XWalk1?	N/A	N/A	Ramp inside XWalk2?	N/A
	Road Slope (%)	N/A	N/A	Clear Space?	Yes
	Road X Slope (%)	N/A	N/A	Clear Space to XWalk (in)	N/A
Yes	Any Obstructions?	No	Yes	Storm Grate/Utility Hazard?	No
	Obstruction Type			Storm Grate/Utility Type	
		N/A			N/A
			Yes	Surface Condition? (G/P)	Good

Remove & Replace Entire Ramp.
