# Access Compliance Report

## Public Rights-of-Way

### (Curb Ramps)

| Intersection ID: 30425 | Main Street: ANNA_ROSE_RD | Cross Street: STEELE_MEADOW_RD | Location: NW |

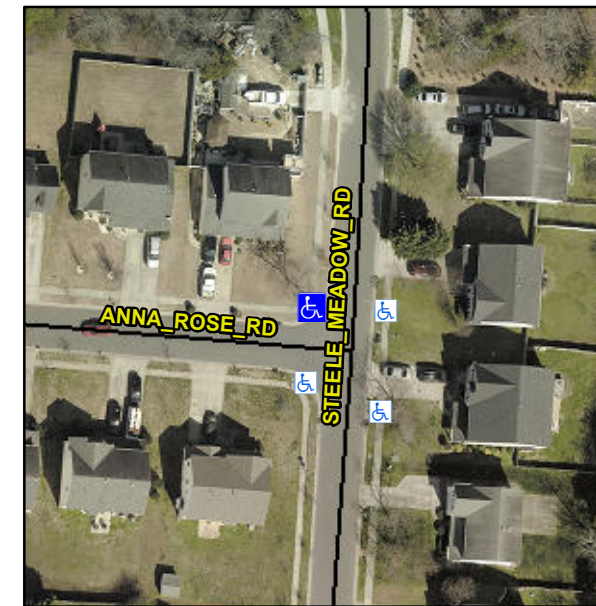
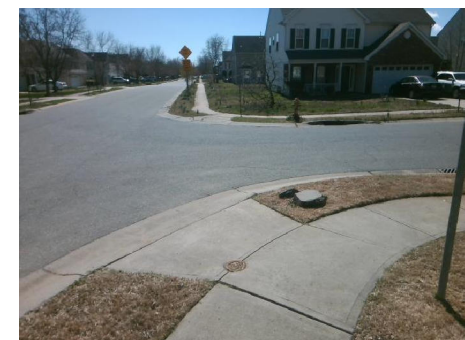
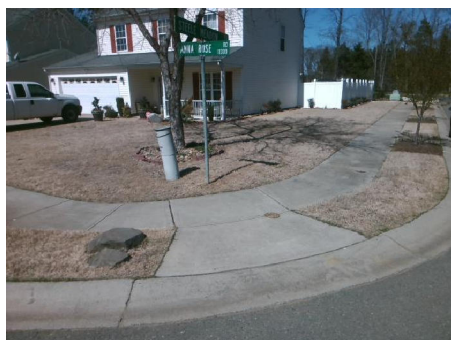
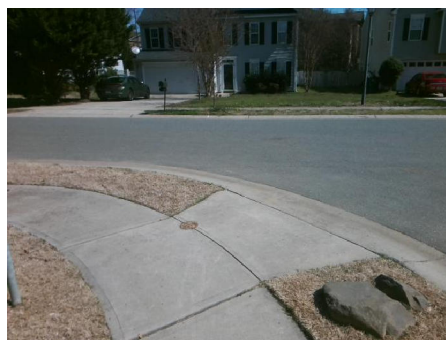
| Compliance | Description | Data | Compliance | Description | Data |
|---|---|---|---|---|---|
| Yes | Landing Length (in) | 49.0 | No | DWS Provided? | No |
| No | Landing X Slope (%) | 3.2 | N/A | DWS Full Width? | No |

Street 1 Name ANNA ROSE RD  
 Stop Condition-Street 1 StopSign  
 Street 2 Name STEELE MEADOW RD  
 Stop Condition-Street 2 None

**Remove & Replace Curb Ramp With Two New Directional Ramps or Equivalent.**

**R304.5.3, R305**

Total Cost: \$ 3200.00
