# Access Compliance Report

## Public Rights-of-Way

### (Curb Ramps)

Intersection ID: N/A	Main Street: INDEPENDENCE_BV	Cross Street: N/A	Location: S
ADA ID: 657068F26EF4	Ramp Type: Perp	Initial Pass/Fail: Fail	Overall Compliance: No
Codes/Mitigation Info/Possible Solution		Field Measurements/Component Compliance	
Severity Score: 13.75

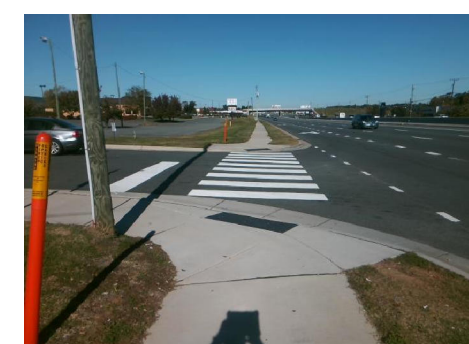
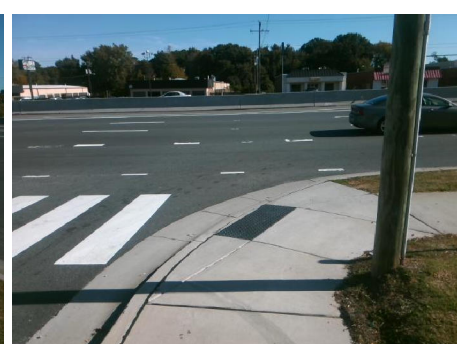
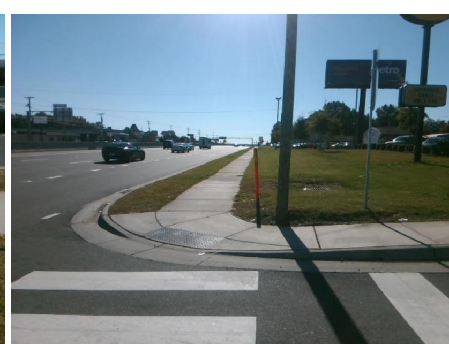
N/A	X Walk 1 Width (in)	120.0	N/A	X Walk 2 Width (in)	N/A
			X Walk 1 Slope (%)	1.1		X Walk 2 Slope (%)	N/A
			X Walk 1 X Slope (%)	2.9		X Walk 2 X Slope (%)	N/A
<p>Street 1 Name</p> <p>Stop Condition-Street 2</p> <p>Street 2 Name</p> <p>Stop Condition-Street 1</p>		N/A	Ramp inside XWalk1?	Yes	N/A	Ramp inside XWalk2?	N/A
			Road Slope (%)	N/A	N/A	Clear Space?	N/A
			Road X Slope (%)	N/A	N/A	Clear Space to XWalk (in)	N/A
		N/A	Any Obstructions?	N/A	N/A	Storm Grate/Utility Hazard?	N/A
			Obstruction Type			Storm Grate/Utility Type	
					N/A		N/A
					Yes	Surface Condition? (G/P)	Good
Total Cost:		\$	1850.00

Possible Solutions:						
	Remove & Replace Entire Ramp.	Compliance	Description	Data	Compliance	Description	Data
		N/A	Ramp Length (in)	27.0	No	Ramp Slope (%)	9.0
		Yes	Ramp Width (in)	59.5	No	Ramp XSlope (%)	2.3
		N/A	Flare Type LT	N/A	N/A	Flare Type RT	N/A
		N/A	Flare Slope LT (%)	N/A	N/A	Flare Slope RT (%)	N/A
		N/A	Flare Traversable LT?	N/A	N/A	Flare Traversable RT?	N/A
		N/A	Landing Length (in)	N/A	N/A	DWS Provided?	N/A
		N/A	Landing Width (in)	N/A	N/A	DWS Contrast?	N/A
		N/A	Landing Slope (%)	N/A	N/A	DWS Length (in)	N/A
<p>Surveyor Notes:</p> <p>N/A</p> <p>PROW/ADA:</p> <p>R304.2.2, R304.5.3</p>		N/A	Landing X Slope (%)	N/A	N/A	DWS Full Width?	N/A
		N/A	Landing Curb? (Y/N)	N/A	N/A	DWS Offset (in)	N/A
		N/A	Shared Landing?	N/A			
		N/A	Gutter Ponding?	N/A	N/A	Gutter Slope (%)	N/A
		N/A	Gutter Lip Ht (in)	N/A	N/A	Gutter X Slope (%)	N/A
		N/A	Painted X Walk1?	Yes	N/A	Painted X Walk2?	N/A
			X Walk 1 Direction	To NW		X Walk 2 Direction	N/A
