# Access Compliance Report

## Public Rights-of-Way

### (Curb Ramps)

| ADA ID: 65751601CF10 | | Ramp Type: Directional1 | | Initial Pass/Fail: Pass | | Overall Compliance: No | | Severity Score: 7.5 | | | | | |

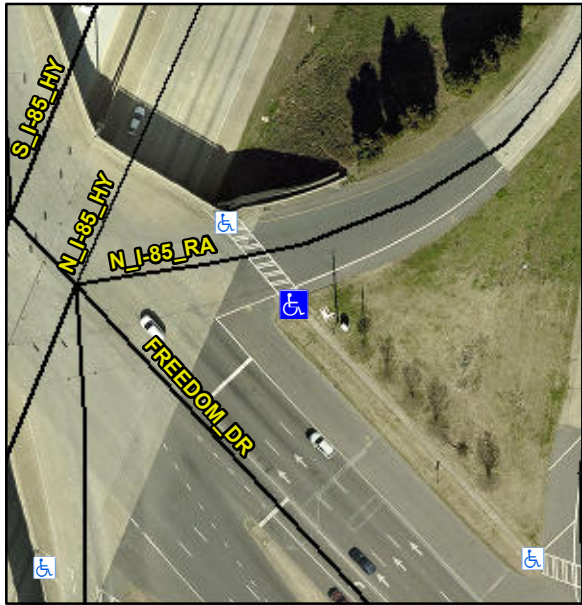
| | | | | No | Landing X Slope (%) | 2.3 | Yes | DWS Full Width? | Yes | | | | |
| | | | | No | Gutter Lip Ht (in) | 0.5 | Yes | Gutter X Slope (%) | 1.4 | | | | |

| <div></div> <div>Possible Solutions:<br/><br/><b>Remove &amp; Replace Entire Ramp.<br/>Grind Gutter Lip.</b></div> <div>Surveyor Notes:<br/><br/><b>N/A</b></div> <div>PROW/ADA:<br/><br/><b>R304.5.3, R305.2, R302.7.2</b></div> | | | | Compliance | Description | Data | Compliance | Description | Data | | | | |
