Access Compliance Report

Public Rights-of-Way

(Curb Ramps)

Intersection ID: 10038507	Main Street: SPEER_BV	Cross Street: PIEDMONT_PARK_DR	Location: W
ADA ID: 657EC244ED5F	Ramp Type: Directional1	Initial Pass/Fail: Fail	Overall Compliance: No
Severity Score: 1.25			
Codes/Mitigation Info/Possible Solution		Field Measurements/Component Compliance

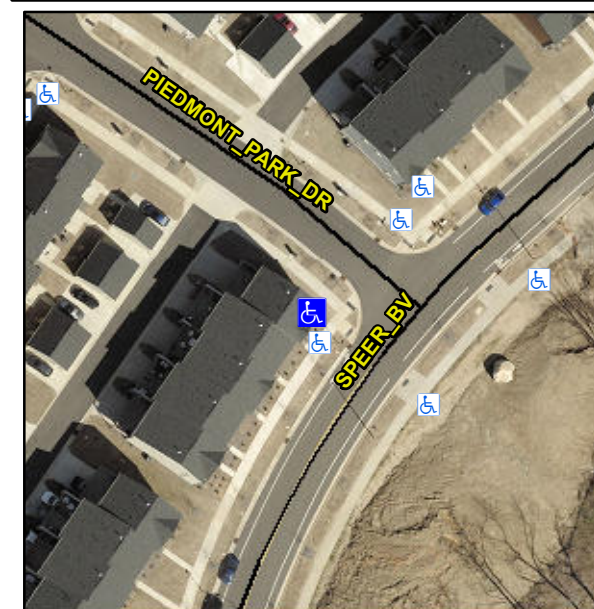
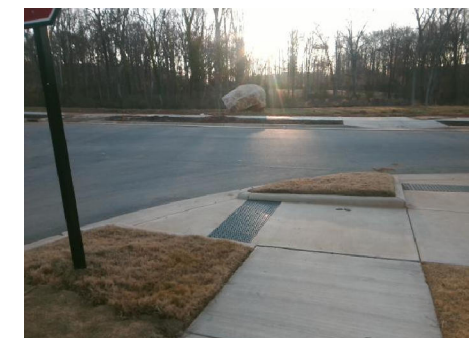
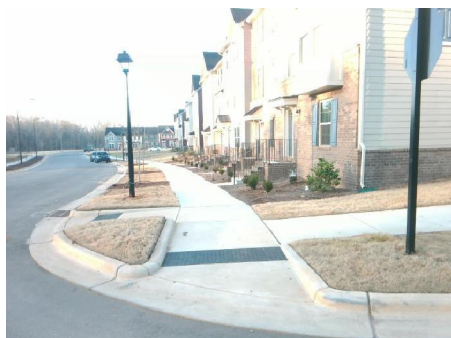
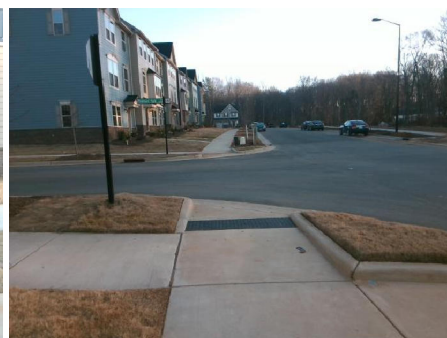
Compliance	Description	Data	Compliance	Description	Data
N/A	Ramp Length (in)	100.0	N/A	Grade Break?	N/A
Yes	Ramp Width (in)	70.5	N/A	Grade Break Slope (%)	0.0
Yes	Ramp Slope (%)	1.0	N/A	Grade Break XSlope (%)	0.0
No	Ramp XSlope (%)	2.2			
N/A	Flare Type LT	N/A	N/A	Flare Type RT	N/A
N/A	Flare Slope LT (%)	N/A	N/A	Flare Slope RT (%)	0.0
N/A	Flare Traversable LT?	N/A	N/A	Flare Traversable RT?	N/A
N/A	Landing Length (in)	0.0	N/A	DWS Provided?	N/A
N/A	Landing Width (in)	0.0	N/A	DWS Contrast?	N/A
N/A	Landing Slope (%)	0.0	N/A	DWS Length (in)	N/A
N/A	Landing X Slope (%)	0.0	N/A	DWS Full Width?	N/A
N/A	Landing Curb? (Y/N)	N/A	N/A	DWS Offset LT (in)	N/A
N/A	Shared Landing?	N/A	N/A	DWS Offset RT (in)	N/A
N/A	Gutter Ponding?	0.0	N/A	Gutter Slope (%)	N/A
N/A	Gutter Lip Ht (in)	0.0	N/A	Gutter X Slope (%)	N/A
N/A	Painted X Walk1?	No		Road Slope (%)	3.1
	X Walk 1 Direction	To NE		Road X Slope (%)	3.7
	X Walk 1 Width (in)	N/A		Clear Space?	N/A

X Walk 1 Slope (%)	3.1	N/A	Clear Space to XWalk (in)	N/A
	X Walk 1 X Slope (%)	3.7	N/A	Storm Grate/Utility Hazard?	N/A
N/A	Ramp inside XWalk1?	N/A		Storm Grate/Utility Type	
N/A	Any Obstructions?	N/A			N/A
	Obstruction Type		Yes	Surface Condition? (G/P)	Good
			N/A	Curb Slope (%)	0.1

Possible Solutions:

Remove & Replace Entire Ramp.

R304.5.3
