# Access Compliance Report

## Public Rights-of-Way

### (Curb Ramps)

Intersection ID: 50586	Main Street: LONGSTRAW_RD	Cross Street: DOWNY_BIRCH_RD	Location: NE
ADA ID: 65860DB20BDA	Ramp Type: Perpendicular	Initial Pass/Fail: Fail	Overall Compliance: No
Severity Score: 22.5			
Codes/Mitigation Info/Possible Solution		Field Measurements/Component Compliance

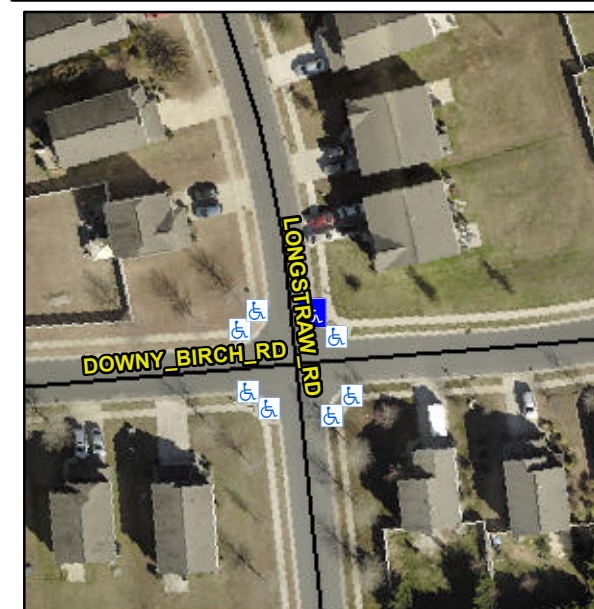
**Not Found, R304.5.1, R304.2.2, R304.5.3**

Compliance	Description	Data	Compliance	Description	Data
N/A	Ramp Length (in)	48.0	No	Ramp Slope (%)	11.4
No	Ramp Width (in)	47.5	No	Ramp XSlope (%)	4.3
N/A	Flare Type LT	N/A	N/A	Flare Type RT	N/A
N/A	Flare Slope LT (%)	N/A	N/A	Flare Slope RT (%)	N/A
N/A	Flare Traversable LT?	N/A	N/A	Flare Traversable RT?	N/A
N/A	Landing Length (in)	N/A	N/A	DWS Provided?	N/A
N/A	Landing Width (in)	N/A	N/A	DWS Contrast?	N/A
N/A	Landing Slope (%)	N/A	N/A	DWS Length (in)	N/A
N/A	Landing X Slope (%)	N/A	N/A	DWS Full Width?	N/A
N/A	Landing Curb? (Y/N)	N/A	N/A	DWS Offset (in)	N/A
N/A	Shared Landing?	N/A			
N/A	Gutter Ponding?	N/A	N/A	Gutter Slope (%)	N/A
N/A	Gutter Lip Ht (in)	N/A	N/A	Gutter X Slope (%)	N/A
N/A	Painted X Walk1?	No	N/A	Painted X Walk2?	N/A
	X Walk 1 Direction	To W		X Walk 2 Direction	N/A
N/A	X Walk 1 Width (in)	N/A	N/A	X Walk 2 Width (in)	N/A
	X Walk 1 Slope (%)	0.8		X Walk 2 Slope (%)	N/A
	X Walk 1 X Slope (%)	2.6		X Walk 2 X Slope (%)	N/A

N/A	Ramp inside XWalk1?	N/A	N/A	Ramp inside XWalk2?	N/A
	Road Slope (%)	N/A	N/A	Clear Space?	N/A
	Road X Slope (%)	N/A	N/A	Clear Space to XWalk (in)	N/A
N/A	Any Obstructions?	N/A	N/A	Storm Grate/Utility Hazard?	N/A
	Obstruction Type			Storm Grate/Utility Type	
		N/A			N/A
			Yes	Surface Condition? (G/P)	Good

Possible Solutions:

**Remove & Replace Entire Ramp.**

Total Cost: \$ 1850.00
