Access Compliance Report

Public Rights-of-Way

(Curb Ramps)

Intersection ID: 10006	Main Street: CALTON_LN	Cross Street: DANIEL_LN	Location: SE
ADA ID: 658F9ACFCA06	Ramp Type: BlendTrans1	Initial Pass/Fail: Fail	Overall Compliance: No
		Severity Score: 17.5

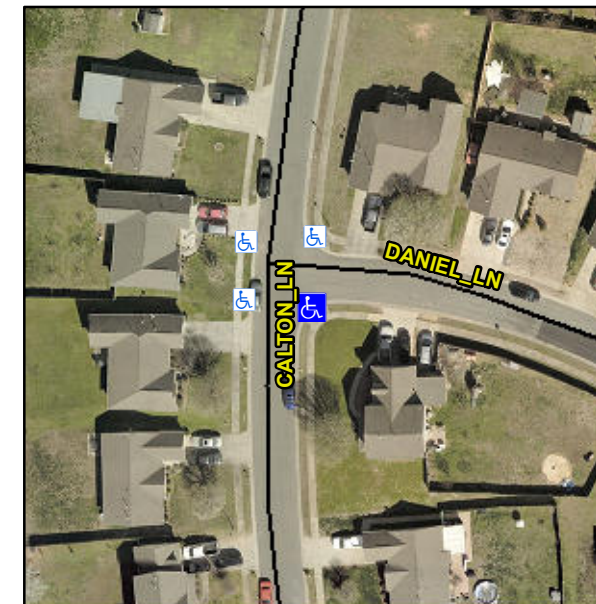
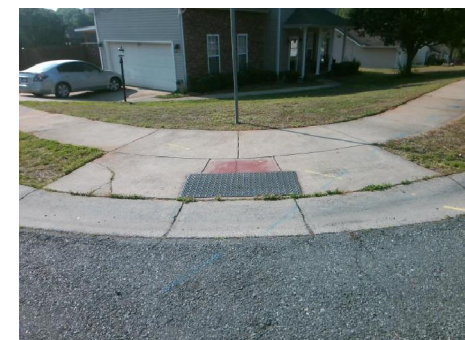
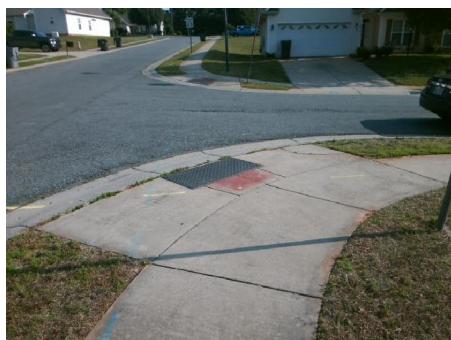
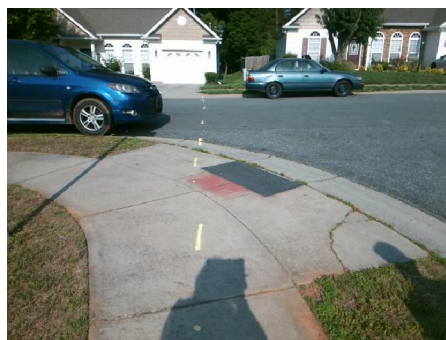
Not Found, R304.5.1

Compliance	Description	Data	Compliance	Description	Data
N/A	Ramp Length (in)	47.0	Yes	BlendTrans Slope (%)	1.0
No	Ramp Width (in)	32.0	Yes	BlendTrans XSlope (%)	2.0
N/A	Flare Type LT	N/A	N/A	Flare Type RT	N/A
N/A	Flare Slope LT (%)	N/A	N/A	Flare Slope RT (%)	N/A
N/A	Flare Traversable LT?	N/A	N/A	Flare Traversable RT?	N/A
N/A	Landing Length (in)	N/A	N/A	DWS Provided?	N/A
N/A	Landing Width (in)	N/A	N/A	DWS Contrast?	N/A
N/A	Landing Slope (%)	N/A	N/A	DWS Length (in)	N/A
N/A	Landing X Slope (%)	N/A	N/A	DWS Full Width?	N/A
N/A	Landing Curb? (Y/N)	N/A	N/A	DWS Offset (in)	N/A
N/A	Shared Landing?	N/A			
N/A	Gutter Ponding?	N/A	N/A	Gutter Slope (%)	N/A
N/A	Gutter Lip Ht (in)	N/A	N/A	Gutter X Slope (%)	N/A
N/A	Painted X Walk1?	No	N/A	Painted X Walk2?	No
	X Walk 1 Direction	To N		X Walk 2 Direction	To W
	X Walk 1 Width (in)	N/A		X Walk 2 Width (in)	N/A
	X Walk 1 Slope (%)	2.2		X Walk 2 Slope (%)	3.6
	X Walk 1 X Slope (%)	4.2		X Walk 2 X Slope (%)	2.1

N/A	Ramp inside XWalk1?	N/A	N/A	Ramp inside XWalk2?	N/A
	Road Slope (%)	2.1		Clear Space?	N/A
	Road X Slope (%)	4.3	N/A	Clear Space to XWalk (in)	N/A
N/A	Any Obstructions?	N/A	N/A	Storm Grate/Utility Hazard?	N/A
	Obstruction Type			Storm Grate/Utility Type	
		N/A			N/A
			Yes	Surface Condition? (G/P)	Good
			No	Curb Slope (%)	13.4

Remove & Replace Curb Ramp With Two New Directional Ramps or Equivalent.

Total Cost: \$ 3200.00
