Access Compliance Report

Public Rights-of-Way

(Curb Ramps)

Intersection ID: 46033	Main Street: DOMINION_VILLAGE_DR	Cross Street: SUMMER_VALLEY_CT	Location: SE
ADA ID: 659FA0928C6A	Ramp Type: Perpendicular Diagonal	Initial Pass/Fail: Fail	Overall Compliance: No
Severity Score: 33.75			
Codes/Mitigation Info/Possible Solution		Field Measurements/Component Compliance

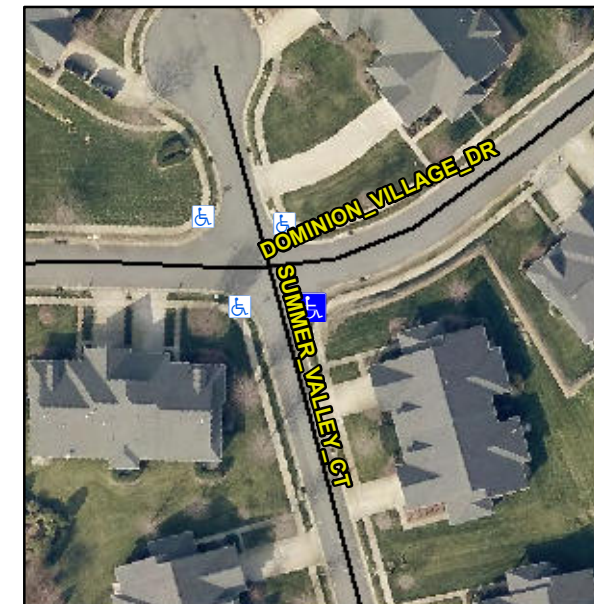
Not Found, R304.5.1, R304.5.3

Compliance	Description	Data	Compliance	Description	Data
N/A	Ramp Length (in)	48.0	Yes	Ramp Slope (%)	5.5
No	Ramp Width (in)	36.0	No	Ramp XSlope (%)	15.5
N/A	Flare Type LT	N/A	N/A	Flare Type RT	N/A
N/A	Flare Slope LT (%)	N/A	N/A	Flare Slope RT (%)	N/A
N/A	Flare Traversable LT?	N/A	N/A	Flare Traversable RT?	N/A
N/A	Landing Length (in)	N/A	N/A	DWS Provided?	N/A
N/A	Landing Width (in)	N/A	N/A	DWS Contrast?	N/A
N/A	Landing Slope (%)	N/A	N/A	DWS Length (in)	N/A
N/A	Landing X Slope (%)	N/A	N/A	DWS Full Width?	N/A
N/A	Landing Curb? (Y/N)	N/A	N/A	DWS Offset (in)	N/A
N/A	Shared Landing?	N/A			
N/A	Gutter Ponding?	N/A	N/A	Gutter Slope (%)	N/A
N/A	Gutter Lip Ht (in)	N/A	N/A	Gutter X Slope (%)	N/A
N/A	Painted X Walk1?	No	N/A	Painted X Walk2?	No
	X Walk 1 Direction	To N		X Walk 2 Direction	To W
N/A	X Walk 1 Width (in)	N/A	N/A	X Walk 2 Width (in)	N/A
	X Walk 1 Slope (%)	13.3		X Walk 2 Slope (%)	0.2
	X Walk 1 X Slope (%)	0.5		X Walk 2 X Slope (%)	7.7

N/A	Ramp inside XWalk1?	N/A	N/A	Ramp inside XWalk2?	N/A
	Road Slope (%)	15.0	N/A	Clear Space?	N/A
	Road X Slope (%)	4.9	N/A	Clear Space to XWalk (in)	N/A
N/A	Any Obstructions?	N/A	N/A	Storm Grate/Utility Hazard?	N/A
	Obstruction Type			Storm Grate/Utility Type	
		N/A			N/A
			Yes	Surface Condition? (G/P)	Good

Remove & Replace Curb Ramp With Two New Directional Ramps or Equivalent.
