Access Compliance Report

Public Rights-of-Way

(Curb Ramps)

Intersection ID: 10015568	Main Street: CARMINE_ST	Cross Street: N/A	Location: NW
ADA ID: 65A6DA385622	Ramp Type: Perpendicular	Initial Pass/Fail: Fail	Overall Compliance: No
		Severity Score: 27.5

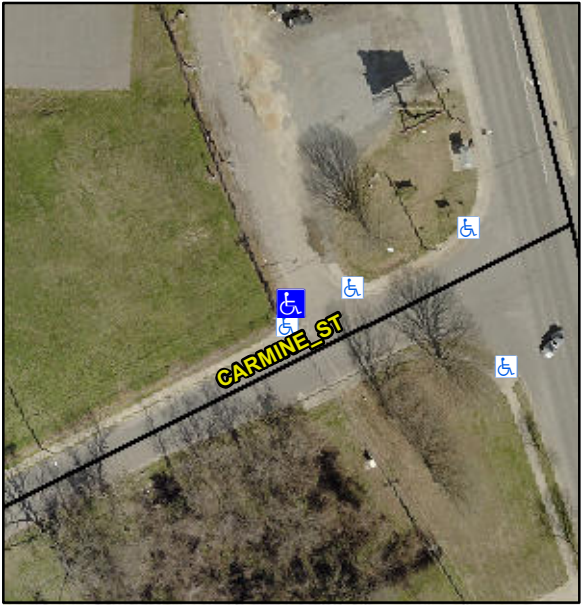
Possible Solutions:		Compliance	Description	Data
	Remove & Replace Entire Ramp.		No	Ramp Length (in)	10.3
			No	Ramp Width (in)	1.1
			N/A	Flare Type LT	N/A
			N/A	Flare Slope LT (%)	N/A
			N/A	Flare Traversable LT?	N/A
			N/A	Landing Length (in)	N/A
			N/A	Landing Width (in)	N/A
			N/A	Landing Slope (%)	N/A
			N/A	Landing X Slope (%)	N/A
			N/A	Landing Curb? (Y/N)	N/A
			N/A	Shared Landing?	N/A
			N/A	Gutter Ponding?	N/A
			N/A	Gutter Lip Ht (in)	N/A
			No	Painted X Walk1?	N/A
				X Walk 1 Direction	N/A
			N/A	X Walk 1 Width (in)	N/A

2.2	X Walk 1 Slope (%)	N/A
			3.1	X Walk 1 X Slope (%)	N/A
			N/A	Ramp inside XWalk1?	N/A
<p>Surveyor Notes:</p> <p>N/A</p> <p>PROW/ADA:</p> <p>Not Found, R304.5.1, R304.2.2, R302.7</p>			N/A	Ramp inside XWalk2?	N/A
			N/A	Road Slope (%)	N/A
			N/A	Road X Slope (%)	N/A
			N/A	Any Obstructions?	N/A
				Obstruction Type	N/A
			N/A		N/A
			No	Surface Condition? (G/P)	Poor
Street 1 Name	ENTRANCE				
Stop Condition-Street 2	StopSign				
Street 2 Name	N/A				
Stop Condition-Street 1	N/A				
Total Cost:		\$ 1850.00
