## Access Compliance Report Public Rights-of-Way (Curb Ramps)

Intersection ID: 27189 Main Street: MCKEE\_RD Cross Street: PROVIDENCE\_ARBOURS\_DR Location: SW

ADA ID: 65AE9BA7989E Ramp Type: Perpendicular Diagonal Initial Pass/Fail: Fail Overall Compliance: No Severity Score: 18.75

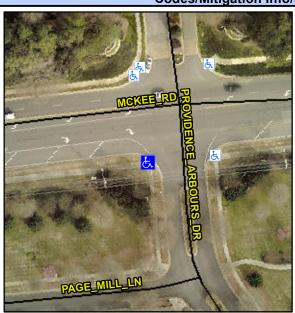
Not Found, R304.5.1, R304.5.3

Field Measurements/Component Compliance					
Compliance Description		Data	Compliance Description		Data
N/A	Ramp Length (in)	89.0	Yes	Ramp Slope (%)	6.2
No	Ramp Width (in)	34.0	No	Ramp XSlope (%)	2.5
N/A	Flare Type LT	N/A	N/A	Flare Type RT	N/A
N/A	Flare Slope LT (%)	N/A	N/A	Flare Slope RT (%)	N/A
N/A	Flare Traversable LT?	N/A	N/A	Flare Traversable RT?	N/A
N/A	Landing Length (in)	N/A	N/A	DWS Provided?	N/A
N/A	Landing Width (in)	N/A	N/A	DWS Contrast?	N/A
N/A	Landing Slope (%)	N/A	N/A	DWS Length (in)	N/A
N/A	Landing X Slope (%)	N/A	N/A	DWS Full Width?	N/A
N/A	Landing Curb? (Y/N)	N/A	N/A	DWS Offset (in)	N/A
N/A	Shared Landing?	N/A			
N/A	Gutter Ponding?	N/A	N/A	Gutter Slope (%)	N/A
N/A	Gutter Lip Ht (in)	N/A	N/A	Gutter X Slope (%)	N/A
N/A	Painted X Walk1?	No	N/A	Painted X Walk2?	No
	X Walk 1 Direction	To E		X Walk 2 Direction	To N
N/A	X Walk 1 Width (in)	N/A	N/A	X Walk 2 Width (in)	N/A
	X Walk 1 Slope (%)	1.8		X Walk 2 Slope (%)	1.3

Remove & Replace Curb Ramp With Two New Directional Ramps or Equivalent.
