# Access Compliance Report

## Public Rights-of-Way

### (Curb Ramps)

| Intersection ID: 48855 | Main Street: NEELY_GLEN_DR | Cross Street: SLEDGE_RD | Location: SW |

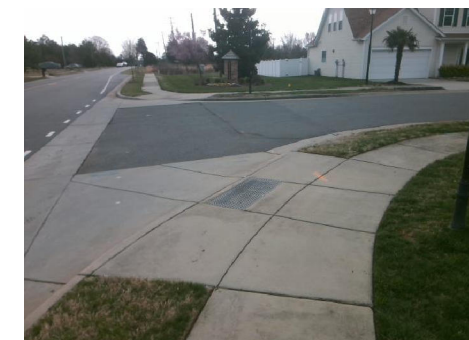
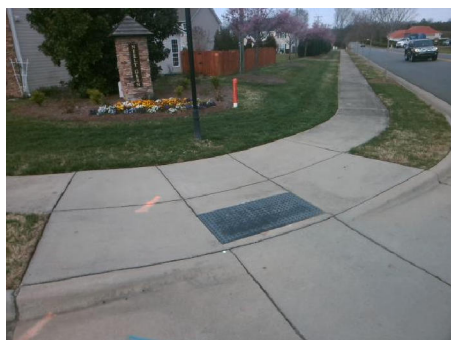
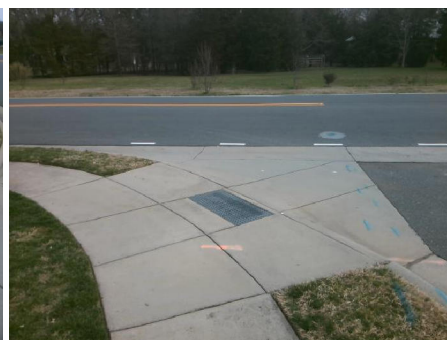
| ADA ID: 65B530B178B5 | Ramp Type: Perpendicular Diagonal | Initial Pass/Fail: Fail | Overall Compliance: No |

**Not Found, R304.5.1, R304.2.2, R304.5.3**

| Compliance | Description | Data | Compliance | Description | Data |
|---|---|---|---|---|---|
| N/A | Ramp Length (in) | 93.0 | No | Ramp Slope (%) | 8.5 |
| No | Ramp Width (in) | 45.0 | No | Ramp XSlope (%) | 3.2 |

**Remove & Replace Curb Ramp With Two New Directional Ramps or Equivalent.**
