# Access Compliance Report

## Public Rights-of-Way

### (Curb Ramps)

Intersection ID: 8063	Main Street: CINDERELLA_RD	Cross Street: PONDELLA_DR	Location: NE
ADA ID: 65B60FF84916	Ramp Type: Perpendicular	Initial Pass/Fail: Fail	Overall Compliance: No
Severity Score: 8.75			
Codes/Mitigation Info/Possible Solution		Field Measurements/Component Compliance

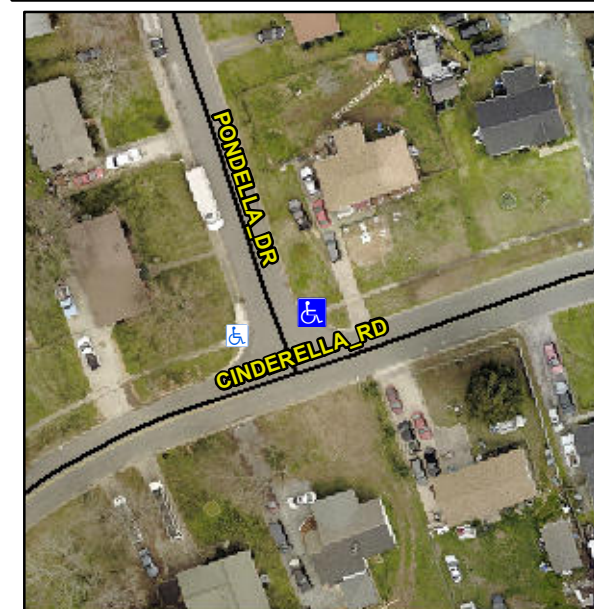
**Not Found, R304.5.1**

Compliance	Description	Data	Compliance	Description	Data
N/A	Ramp Length (in)	31.0	Yes	Ramp Slope (%)	7.6
No	Ramp Width (in)	47.5	Yes	Ramp XSlope (%)	1.4
N/A	Flare Type LT	N/A	N/A	Flare Type RT	N/A
N/A	Flare Slope LT (%)	N/A	N/A	Flare Slope RT (%)	N/A
N/A	Flare Traversable LT?	N/A	N/A	Flare Traversable RT?	N/A
N/A	Landing Length (in)	N/A	N/A	DWS Provided?	N/A
N/A	Landing Width (in)	N/A	N/A	DWS Contrast?	N/A
N/A	Landing Slope (%)	N/A	N/A	DWS Length (in)	N/A
N/A	Landing X Slope (%)	N/A	N/A	DWS Full Width?	N/A
N/A	Landing Curb? (Y/N)	N/A	N/A	DWS Offset (in)	N/A
N/A	Shared Landing?	N/A			
N/A	Gutter Ponding?	Yes	N/A	Gutter Slope (%)	N/A
N/A	Gutter Lip Ht (in)	N/A	N/A	Gutter X Slope (%)	N/A
N/A	Painted X Walk1?	No	N/A	Painted X Walk2?	N/A
	X Walk 1 Direction	To W		X Walk 2 Direction	N/A
N/A	X Walk 1 Width (in)	N/A	N/A	X Walk 2 Width (in)	N/A
	X Walk 1 Slope (%)	7.7		X Walk 2 Slope (%)	N/A
	X Walk 1 X Slope (%)	1.5		X Walk 2 X Slope (%)	N/A

**Remove & Replace Entire Ramp.**

Total Cost: \$ 1850.00

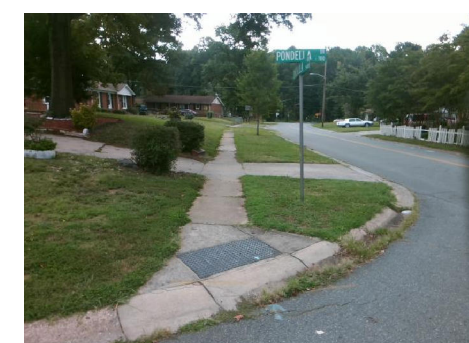
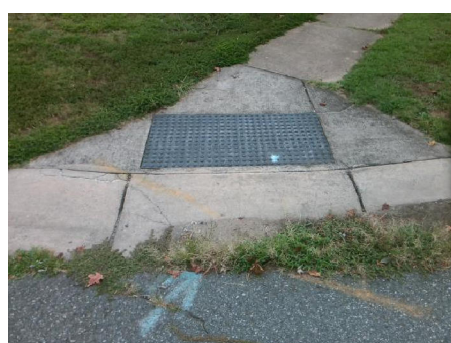
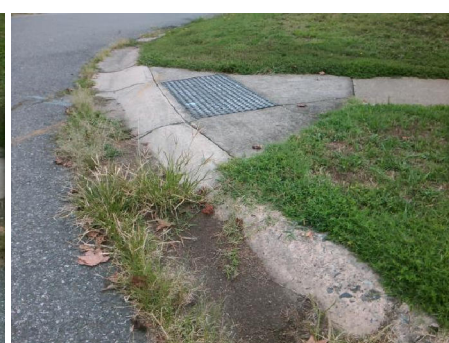
N/A	Ramp inside XWalk1?	N/A	N/A	Ramp inside XWalk2?	N/A
	Road Slope (%)	N/A	N/A	Clear Space?	N/A
	Road X Slope (%)	N/A	N/A	Clear Space to XWalk (in)	N/A
N/A	Any Obstructions?	N/A	N/A	Storm Grate/Utility Hazard?	N/A
	Obstruction Type			Storm Grate/Utility Type	
		N/A			N/A
		Yes		Surface Condition? (G/P)	Good
