Access Compliance Report

Public Rights-of-Way

(Curb Ramps)

Intersection ID: 13833	Main Street: WEST_BV	Cross Street: WALTON_RD	Location: SW
ADA ID: 65BD8A654A78	Ramp Type: Perpendicular Diagonal	Initial Pass/Fail: Fail	Overall Compliance: No
		Severity Score: 22.5

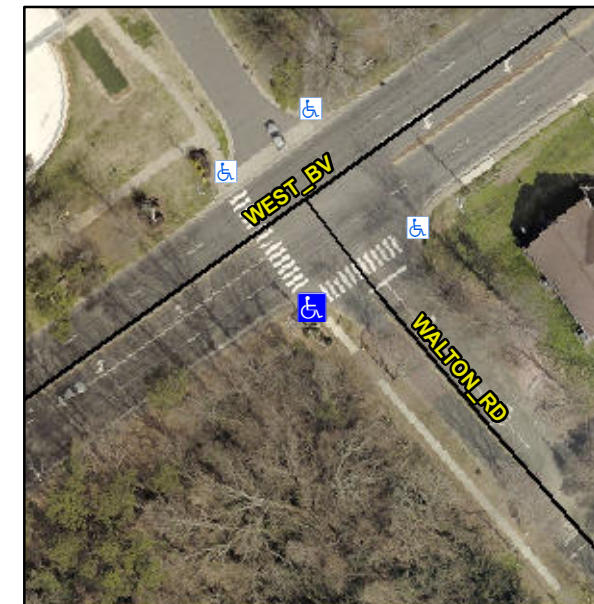
Not Found, R304.5.1, R304.2.2, R304.5.3

Compliance	Description	Data	Compliance	Description	Data
N/A	Ramp Length (in)	50.0	No	Ramp Slope (%)	9.3
No	Ramp Width (in)	40.0	No	Ramp XSlope (%)	4.3
N/A	Flare Type LT	N/A	N/A	Flare Type RT	N/A
N/A	Flare Slope LT (%)	N/A	N/A	Flare Slope RT (%)	N/A
N/A	Flare Traversable LT?	N/A	N/A	Flare Traversable RT?	N/A
N/A	Landing Length (in)	N/A	N/A	DWS Provided?	N/A
N/A	Landing Width (in)	N/A	N/A	DWS Contrast?	N/A
N/A	Landing Slope (%)	N/A	N/A	DWS Length (in)	N/A
N/A	Landing X Slope (%)	N/A	N/A	DWS Full Width?	N/A
N/A	Landing Curb? (Y/N)	N/A	N/A	DWS Offset (in)	N/A
N/A	Shared Landing?	N/A			
N/A	Gutter Ponding?	N/A	N/A	Gutter Slope (%)	N/A
N/A	Gutter Lip Ht (in)	N/A	N/A	Gutter X Slope (%)	N/A
N/A	Painted X Walk1?	Yes	N/A	Painted X Walk2?	Yes
	X Walk 1 Direction	To NE		X Walk 2 Direction	To NW
N/A	X Walk 1 Width (in)	123.0	N/A	X Walk 2 Width (in)	121.0
	X Walk 1 Slope (%)	0.0		X Walk 2 Slope (%)	2.9
	X Walk 1 X Slope (%)	3.4		X Walk 2 X Slope (%)	0.9

N/A	Ramp inside XWalk1?	Yes	N/A	Ramp inside XWalk2?	Yes
	Road Slope (%)	2.5	N/A	Clear Space?	N/A
	Road X Slope (%)	2.5	N/A	Clear Space to XWalk (in)	N/A
N/A	Any Obstructions?	N/A	N/A	Storm Grate/Utility Hazard?	N/A
	Obstruction Type			Storm Grate/Utility Type	
		N/A			N/A
		Yes		Surface Condition? (G/P)	Good

Remove & Replace Curb Ramp With Two New Directional Ramps or Equivalent.
